## **THE IMPACT OF LANDSLIDES ON THE DN15 NATIONAL ROAD IN THE AREA OF THE IZVORU MUNTELUI – BICAZ RESERVOIR**

**Abstract.** In the 47 years of utilization, landslides have had destructive effects on the DN 15 national road and on some of the accompanying constructions (retaining walls, bridges etc.). Studies conducted by researchers from different fields (geomorphology, climatology, geology, hydrology and hydrogeology) have had as purpose the identification of the complex of natural and anthropic causes that have contributed to the triggering of these processes and the search for solutions for risk diminishing. Also, these studies have been the base for execution projects of consolidation works of the national road in the affected sectors.

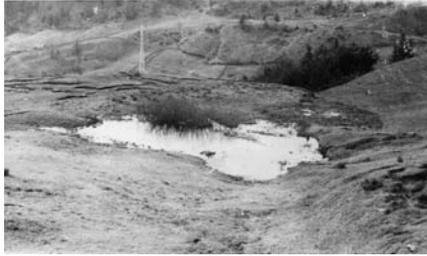
The fact that the slope surfaces affected by landslides were easily identifiable, the scarps being visible from distance, allowed the estimative evaluation of the vulnerability degree and of the risk of landslide occurrence (Fig. 2 and 3). As a consequence, special attention was given to geotechnical studies. Thus were determined the rock characteristics, depth of debris body and the localization of surfaces affected by humidity excess. Based on these studies were conducted works

Fig. 2. Landslide area on the left slope of Potoci gulf, 1966 (Photo I. Cărăușu)

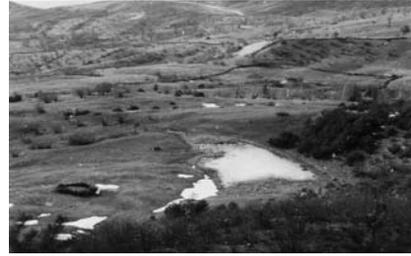
Fig. 3. Area with landslides at Huiduman, 1966 (Foto I. Cărăușu)

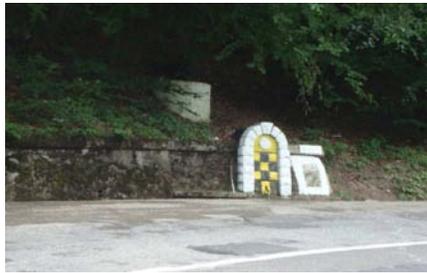
Fig. 4. Consolidation with retaining walls and spring alimented with water from the drain upstream Motel Cristina

for landslide mitigation: retaining walls, drains for eliminating water excess, Japanese wattleworks. The great majority of these works is functional at the present (Fig. 4).

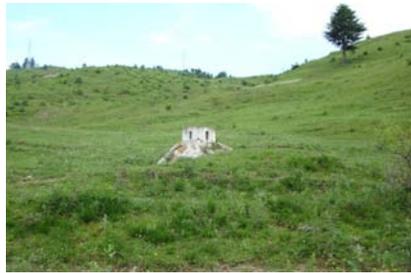
Fig. 5. Drains in an area with landslides and humidity excess

The crossing of the slopes intensely fragmented by brooks and small torrential organisms and affected by intense landslides extended on large surfaces, with humidity excess, has raised many problems even during construction. To overcome the natural obstacles from the area was needed the emplacement of a large number of slope consolidation works, were emplaced earthworks and cut-and-fills which also needed retaining walls. On the terrains with excessive humidity was emplaced a network of drains (Fig. 5).

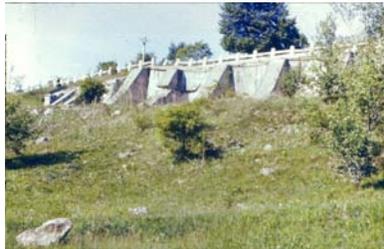
With all the efforts made for these consolidation works, in only one year from the construction finalization, in 1965, was witnessed the existence on the road of 70 sectors strongly affected by landslides (Fig 6).

Fig. 6. Consolidation with arches with pilasters on the affected DN 15 at Grozăvești

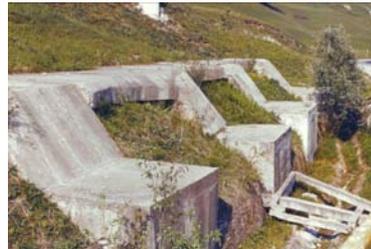
Fig. 7. Anchoring pile arches at the Vale Bubei viaduct

The impact of the landslides has been severe, overcoming the estimations of the constructors. The most affected areas have been Buba and Huiduman. In the torrential basin of Buba was needed to be emplaced canal embankments, drains, bank-sloping arcades, arches with pilasters and retaining walls (Fig. 7).

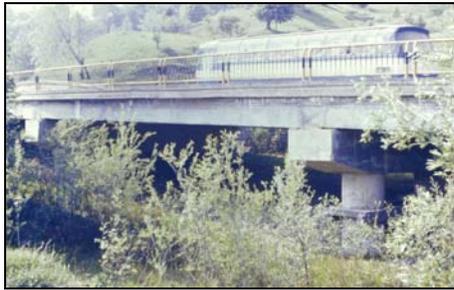
1. *Buba torrential catchment*, km 247+925 – 247+990. The energy discharges exerted by the landsliding deluvial mass on the road platform from the area provoked very large destructions. To allow circulation again was constructed a Benotto piles viaduct over the landslide body (Fig. 9). There were also undertaken

works for the consolidation of the landslide area uphill the viaduct and organizing water drainage. During the execution of the viaduct landslides have intensified and have broke the freshly installed concrete pillars from pile P2 at about 3 meters from the terrain level. Thus was needed to replace the broken parts, to reconstruct the pillars up to the initial level and consolidating them with strongly enforced sill plates. At the same time, upstream the viaduct was executed a consolidation with strengthening coffered united by reinforced concrete arches on pillars emplaced with the help of drop hammers. Later the P2 pile has been anchored for consolidation with the help of metallic grubs protected by concrete.

In 1980, approximately 3 years from the end of the constructions, was witnessed a reactivation of the landslide, which caused the destruction of the canal embankment at the exit from the viaduct.

Fig. 9. Valea Bubei viaduct

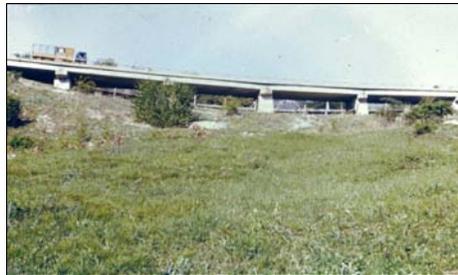
2. *Huiduman catchment*, km 258+585 - 258+675. In the same period (1972-1973) the road platform was degraded partially or totally on a length of 90 m. Due to the large depth at which the bedrock is found (8-12 m) was decided that for the crossing of this area a viaduct on Benotto pillars was needed. The viaduct has 6 openings of 15 m (Fig. 10).

Fig. 10. Viaduct and drains at Grozăvești (Darie)

The infrastructures anchored in the bedrock (sandstones alternating with marls) are made of piles each on three Benotto pillars. The viaduct was not designed to support the pressure of the whole slope. As in the previous case the viaduct behaved well from the moment it was finished in 1974 up to 1977, when fissures in the pillars and in the strengthening beams occurred. Because the state of the viaduct was not proper for circulation, another one was built upstream it, in parallel taking place the repairing works on the degraded portion. Thus were executed the covering of the broken pillars in steel concrete that reach a depth of 10-12 m from the lower level of the beams. During these works were intercepted springs with a discharge rate of 2-4 l/min which haven't been previously detected in the geotechnical studies. It was considered that the occurrence of the springs has been caused by infiltrations due to a repositioning of the strata after the 1977 earthquake. As a consequence was conducted a work of strengthening the viaduct in the downstream part, with draining caissons buried at 8-9 m from the terrain level, linked between them through a network of drains. The execution of the works has been cumbered by the fact that in the deluvial mass were found large rock blocks which have hardened the positioning of the caissons.

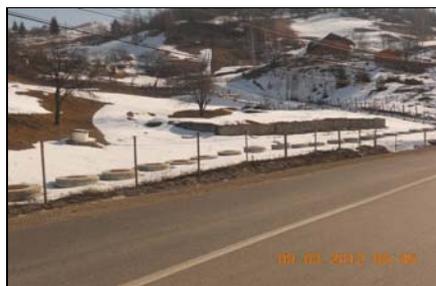
Fig. 11. Drain network on DN 15

3. *Huiduman catchment*, km 259+200-259+324. Here occurred reactivations of old landslides, mentioned in the geotechnical studies even from the design phase in 1958. During 1965 was constructed a legged abutment wall which was again affected by landslides in 1969. The landslides from the area have a distinct delapsive character, being triggered from downstream the road, from the margin of the lake and ending upstream de road. It is considered that the large variations of the lake level decisively contribute to a permanent state of terrain instability, due to the short distance to the lake shore. Thus have been strongly affected a series of buildings upstream the road which have later been demolished. The road has been consolidated with pillars in the area of the abutment wall, which was continued

later with arches on pillars. At the same time was constructed a longitudinal drain under the road ditch which collects the smaller drains from the area (Fig. 11).

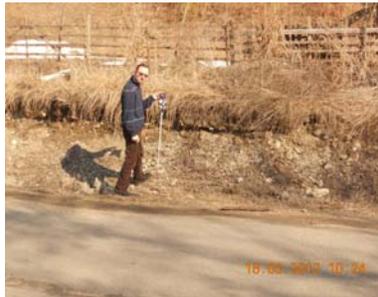
During 16.02 - 18.03.2012 were conducted a series of field observations in the area and have been observed a reactivation uphill Grozăvești viaduct, which led to a displacement of buildings from the near vicinity and a subsidence of the DN 15 road platform of over 70 cm in comparison to the initial level (Fig. 12 and 13).

Fig. 12. Subsidence of DN 15 road platform at Grozăvești

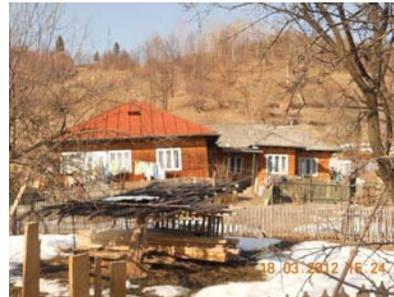
Fig. 13. Building displacement, Grozăvești

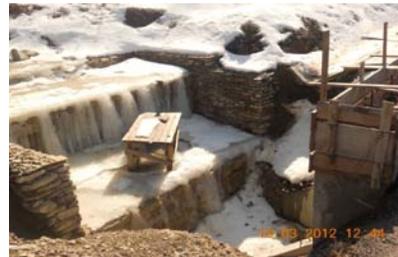
In the same period it was noticed that on the road from the dam to Poiana Largu all the brooks were depleted although at the end of the second decade of February 2012 were registered heavy snows (Fig. 14). Immediately downstream Vârlan brook were conducted some flood control works for a small torrent that had affected the road platform (Fig. 15).

Fig. 15. Flood control works downstream Vârlan brook
