## ANALYSIS OF THE HYDROCLIMATIC RISK PARAMETERS AT THE HIGH LEVEL OF THE TAZLĂUL SĂRAT RIVER IN 2016 YEAR

Mihail Luca<sup>1</sup>, Mihaela Avram<sup>2</sup>

**Abstract.** The paper presents an analysis of the hydrological risk parameters registered in June 2016 in the catchment area of the Tazlăul Sărat River. The studies and researches were carried out on the upper course of the river, in the area between Zemeş and Toderăş, the commune of Zemeş, Bacău county. The river basin of the Tazlăul Sărat River has been affected by several floods in recent years. The floods have morphologically modified the minor and the major river bed, which has influenced the stability of the county road and the river construction. The study focused on the analysis of precipitation and liquid flows over a period of 20 years. Processing of liquid flow data revealed more flood flows in the same year. In 2016 there was a flow of 342 m<sup>3</sup> / s (probability of 3%). The effects of the floods have materialized through the excessive degradation of shore defence works until their total destruction. The degradation of shore defence works has contributed to breaking the county road and limiting the road

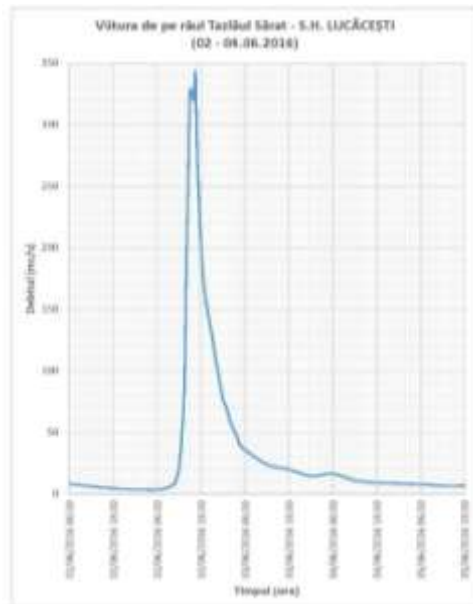
The flood wave formed in June 2016 on the Tazlăul Sărat River showed a flow rate of 342 m<sup>3</sup>/s, a value approaching the 3% probability (Table 3, Fig. 2).

The flood on the Tazlăul Sărat River started on 02.06.2016, at 10.00, with a 69 cm share and a flow of 6.70 m<sup>3</sup>/s. The peak of the flood was recorded on 02.06.2016, at 16.30, where the quota reached 360 cm and a maximum flow of 342m<sup>3</sup>/s. The 2.73 m flood gauge has overtaken the banks and has caused major

floods and damage. The probability of exceeding the maximum flow rate (Luca M., 2016).

Fig. 2. The flood level hydrograph on the Tazlăul Sărat river, the Lucăcești H.S.

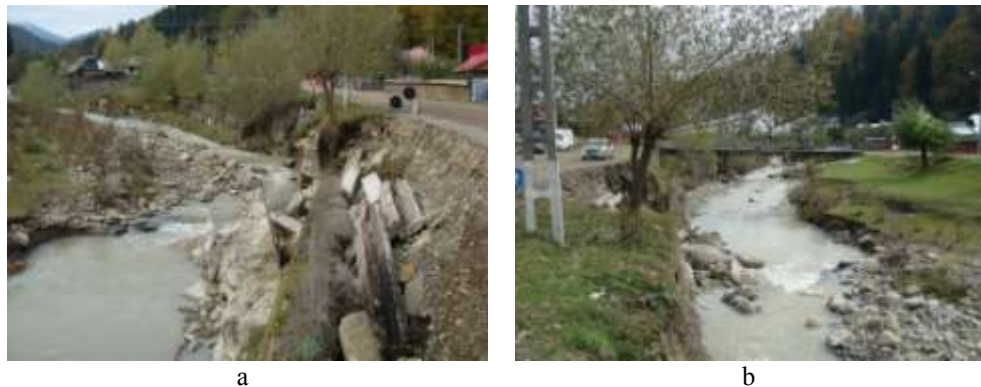
*Zone 1 - "Toderaş".* The shore defence is executed from a simple concrete wall to the road elevation. The shore defence was degraded by 40-90% over a length of 60 m. The flood waves have morphologically modified the Tazlăul Salt Riverbed in the "Toderaş" curvature area, causing the bedding to be dampened and the tallo descended, which influenced the shore defence behaviour and the degradation over time. The defence of the wall of a support wall made of simple concrete, located on the left bank in the curvature area, was completely destroyed in the central section (Fig. 4). The river also acts on small water on the bank, resulting in the continuous degradation of the structural components of the defence and further on the foundation layer of the communal road.

Fig. 4. General view of the morphology of the Tazlăul Sărat riverbed and the state of degradation of shore defence and DC 180A in Zone 1 "Toderaş": a - general view from downstream with highlighting the erosion of the road; b - upstream view (Oct 2016)

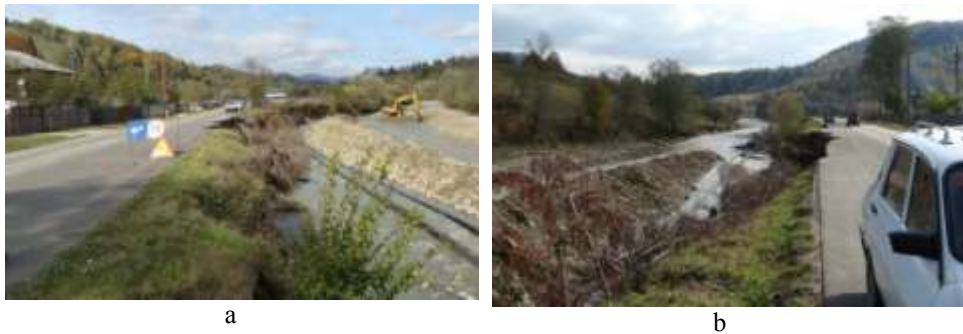
*Zone 3. "Chiosa".* The Tazlăul Sărat River has a right curve in this area, after which it maintains a linear downstream (Fig. 5a). At the end of the curve, the riverbed and the left bank lie near the DC 180A communal road.

Fig. 5. The degradation phenomena of the riverbed in Zone 3, "Chiosa" after the flood in June 2016 on the Tazlăul Sărat River: a - upstream view of the river bed change and erosion; b - downstream view, highlighting oil piping and breaking the DC180A (photo Oct 2016)

shoreline and shoreline construction. The unprotected bank of the Tazlăul Sărat River was eroded on a length of 80 m and an entrance to the shore of 0.5-5.0 m.

The erosion phenomenon has caused road breakage and traffic constraint. Crude oil pipelines and electric cables are located (buried) in the shore area. The erosion of the shore caused the pipes to be cut off and suspended (Fig. 5.b). The field analysis did not reveal the presence of shore defence.

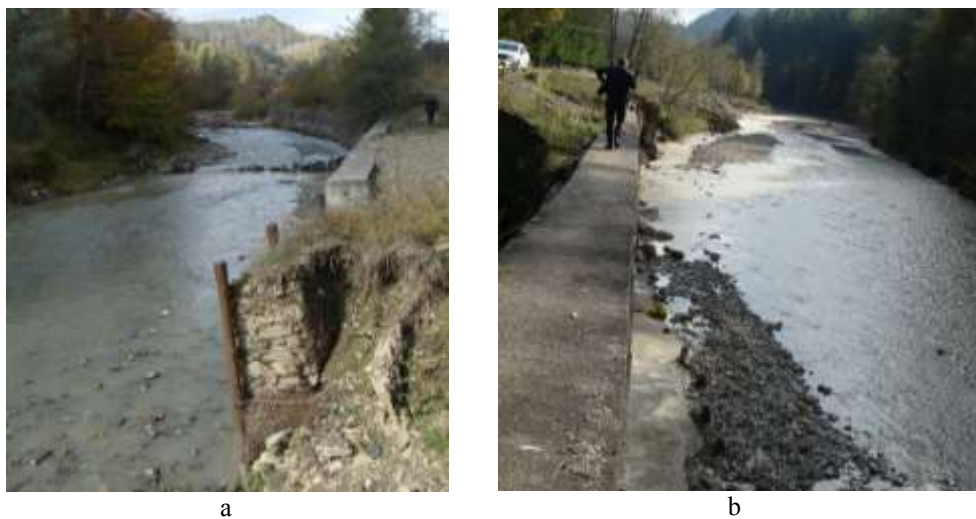
Fig. 6 - General view of the evolution bed of the Tazlăul Sărat River in area 4 "The Forest Canton Maxim": a - upstream view of the erosion area; b - downward view (photo Oct 2016)

*Zone 4. "Forest Canton Maxim".* The Tazlăul Sărat River bed has an approximately trapezoidal shape in this area, with a bottom width of about 16.0 m and a height up to the crown of the shore defence of 4.0 m. The left bank is vertical, being made by shore defence, and the right bank shows a slop slope 1: 0.5-0.8.

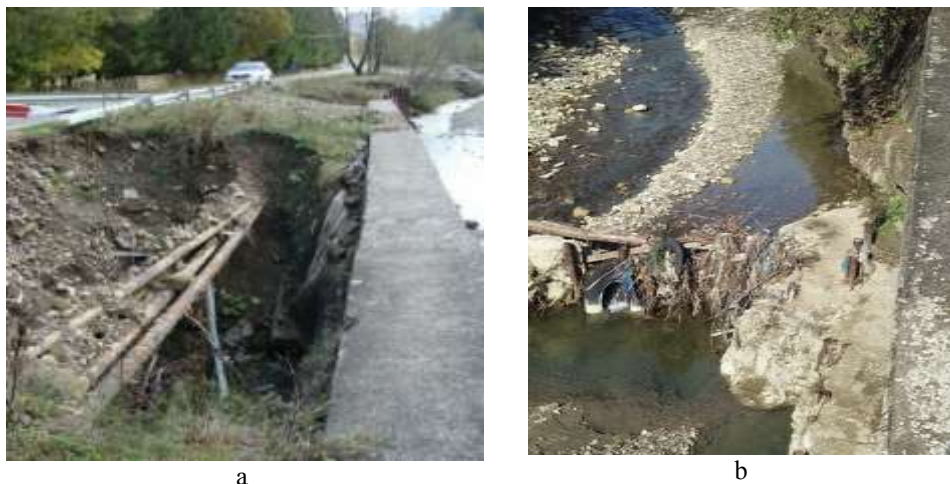
The first sub-area is located at the entrance to the analyzed riverbed sector, where the shore defence consists of a support wall made of plain concrete (foundation height - 1.00 m, elevation height 3.00 m, crown thickness 0.80 m). The water flow in the curvature area has a high velocity, causing an erosion phenomenon of the thalweg and the left bank.

The lowering of the thalweg has influenced the stability of the support wall foundation. The foundation has been scattered over its entire length over a relatively long time (Fig. 7.b). The water penetrated under the foundation and made several flow paths in the massive bed of cohesive material of the bed. Through these voids, an infiltration stream or pressurized water jet was formed, which

Fig. 7. Erosion phenomenon of the left bank after the flood in June 2016 on the Tazlăul Sărat River in Zone 4 "Forest Canton of Maxim": a - general view of the erosion zone behind the shore defence at the DC 180A limit; b - fencing phenomenon in the shore defence foundation area (Oct. 2016)

washed the filler material behind the support wall (Figure 7.a). The erosion phenomenon of the water jet continued to the ground (Fig 7). The erosion pit

behind the supporting wall reached a width of 4.80 m, out of which 1.90 - 2.00 m have developed in the structure of the road (Luca M., 2016).

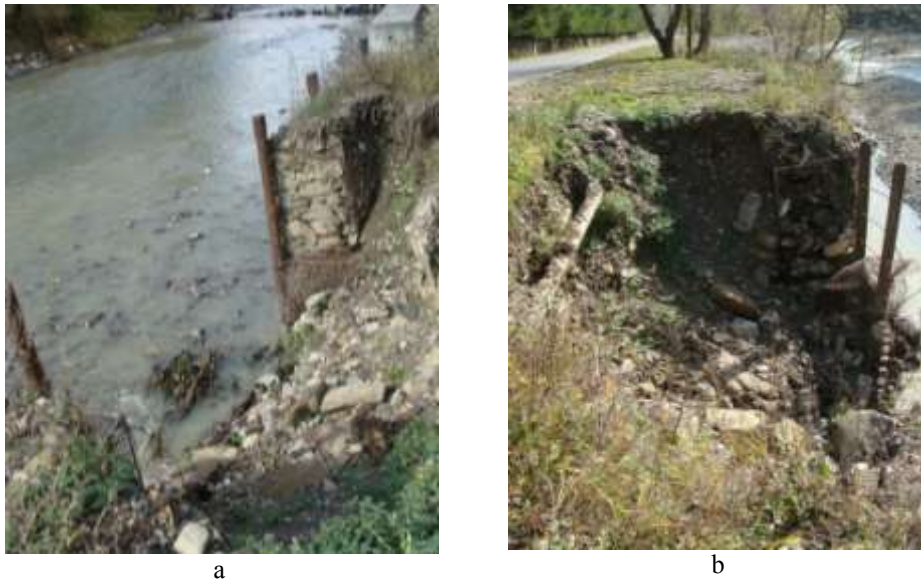
Fig. 8. Degradation of shore defence and erosion of the left bank of the Tazlăul Sărat River, the second erosion section, zone 4 "The Forest Canton Maxim": a - destruction of shore defence; b - upstream view (downstream river bed and unpacking of oil pipelines, Oct. 2016)

The second sub-area is located downstream to about 25.0 m from the first. The shore defence consists of a support wall made of gabion boxes. The water flow in the curvature area, guided by the simple concrete support wall, has created a strong erosion phenomenon here. The effect materialized through the destruction of the shore defence (gabion box support wall) on a length of about 15.0 m (Fig. 8). The erosion phenomenon continued until the road foundation (Luca M., 2016).

The degradation phenomenon of the left bank is influenced by the stable shape of the riverbed towards the right bank and by the limitation of the development of a meander to the left by the river. The hydraulic energy of the water stream turns into a mechanical deformation of the left bank in the curvature area. At the end of the road and on the bank of the river oil pipelines are buried. The erosion phenomenon of the bank and further on the road caused the pipes to be cut off and suspended. Pipeline degradation can lead to a strong oil pollution phenomenon on the Tazlăul Sărat River (Luca M., 2016).
