PESD, VOL. 12, no. 2, 2018

## STUDIES AND RESEARCH ON NATURAL AND ANTHROPIC RISK THE MOLDOVA'S LOWER COURSE

**Key words:** constructive degradation, erodible riverbed, morphology, shore defence

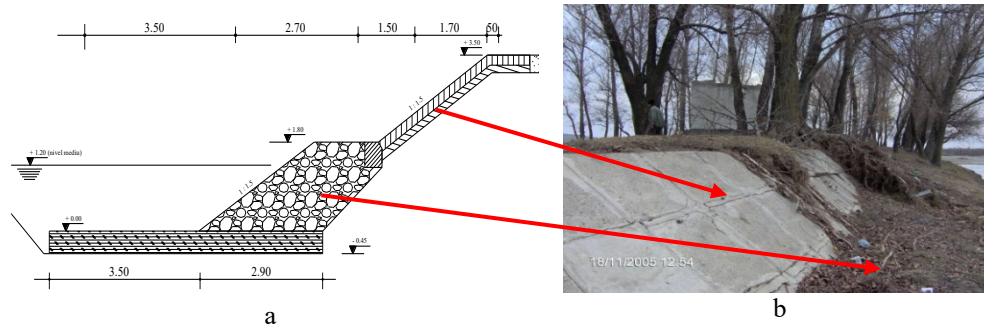
Research carried out between in the period 2004 - 2015 analyzed in detail the degraded phenomenon of shore defence works in the undercrossing area of the adduction pipes. The shore defence was carried out in 1971. It consists of two overlapping constructive structures (Figures 7.a, 7.b). The first structure is a massive stone 1.80 m high on a fascia mattress. The second structure consists of concrete slabs (50x50x10 cm) mounted on a ballast bed and supported on a simple concrete beam. The tile wall has a tilt slope of 1: 1.5 and is mounted at a height of 1.70 m (Figure 7.a). On-site research analyzed how the construction behaved over time at site factors.

During the first years of exploitation there was a clogging of the shores defence works. During the period 2005 - 2015 the hydrological and hydraulic regime was modified on the section with the undercrossing construction located on the Moldova River. Natural risk factors, corroborated with those of anthropogenic risk, have accelerated the degradation of shore defence works until their total destruction. The degradation of shore defence works was more intense on the left

Fig. 7. Images of the protection works on the Moldova River: a - execution detail; b - shore defence in 2005.

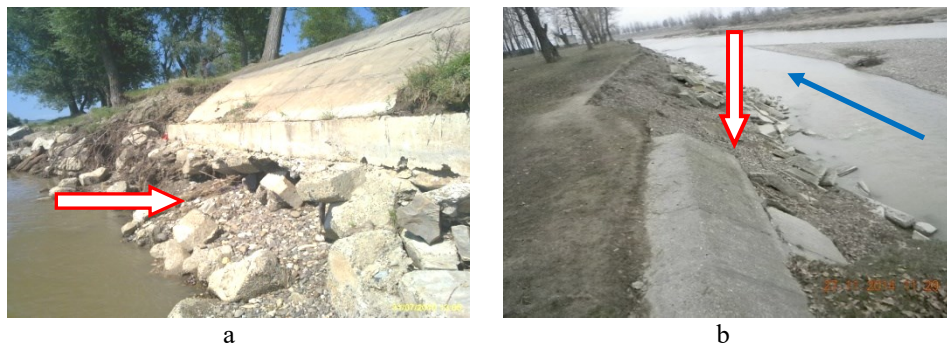
The degradation of shore defence works was carried out through the following destructive processes during the years 2005 - 2012. The degradation process included the steps: a - washing the alluvial offshore defence (Figure 9.b); b - removing the cement mortar from the joints and washing the ballast layer under the tiles; c - cracking and cracking of concrete slabs; d - the entrainment of the rock from the supporting mass and the collapse of the defence structure (Fig. 9.a); e - breaking of the support beam and the collapse of the concrete slabs; f - the entrainment of concrete pieces in the riverbed and the erosion of the bank (Fig. 9.b) (Luca M., 2012).

Fig. 9. Images of the protection works on the Moldova River: a - degraded left bank defence (2012); b - total left destroyed defence (year 2012) (Luca M., 2012).

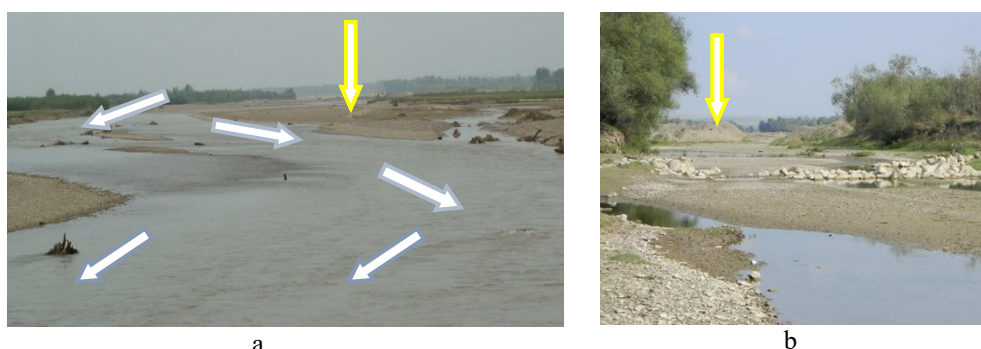
The accumulation of natural risk factors in the study area (floods, maximum flows, high frequency of peak flows, erosions, noncohesive rocks in the basin of the riverbed) with the anthropic ones (ballast exploitation, deforestation, absence of regulation and shore defence, the extension of the arable land) caused excessive degradation of the riverbed in the transverse and longitudinal plane (Fig. 11).

The excessive morphological modification of the riverbed caused the degradation of the stability and integrity of the adduction pipes Timisesti - Drinking for drinking water. Also, shore defence works and regularization works have been degraded differentially on both sides of the river. The shore defence on the right arm of the Moldova River was degraded by 90%, where the anthropic factor (ballast exploitation) occurred substantially.

Fig. 11. Anthropogenic risk factors (ballast exploitation) in the morphological modification of the river bed of Moldova: a - anthropic modification of the river flow paths; b - partial blocking of flow ballast deposits through the right arm of the river in the research area.
