## RESEARCHES ON BEHAVIOUR OF REGULATION WORKS LOCATED IN MORPHOLOGICALLY UNSTABLE RIVER BEDS

Paul Vivian Sion<sup>1</sup>, Mihail Luca<sup>2</sup>, Ilie Logigan<sup>3</sup>, Mihaela Avram<sup>1</sup>

**Keywords:** bottom sill, geo-bags, geotextile, hydrodynamic erosion

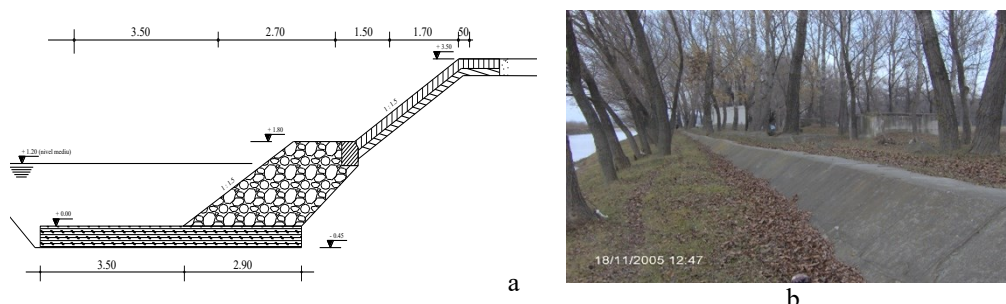
- The shore protection works were carried out in four constructive solutions (A1, A2, A3, A4) and contain a plain concrete slab measuring  $50 \times 50 \times 10 \text{ cm}$ , supported on a concrete beam, a stone prism as a foundation, and a fascine mattress in contact with the bedrock (Fig. 3) (Luca, 2012).

Figure 3: The Moldova River left shore protection: a - building scheme; b - view of shore protection in 2005 with emphasis on the silting area (Luca, 2012).

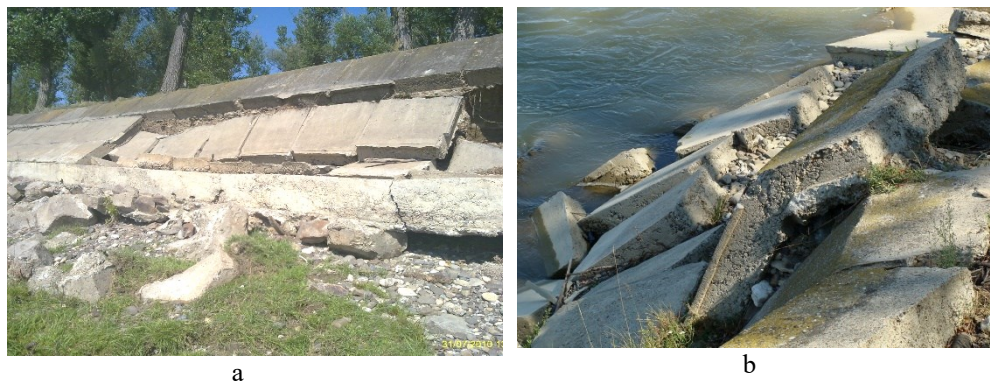
- the erosion and removal of the rock under the shore protection foundation, a situation which led to the displacement of the large stone prism and the washing of the material during floods;

- under pressures behind the concrete slabs, with the washing of the support layer, joints degradation, situations that caused cracks and fragmentation of the slabs with their expulsion from the embankment;

- the stone prism removal has resulted in the breaking of the concrete beams supporting the tiles; this situation led to the collapse of tiles and the direct water action on the shore (Fig. 4);

Figure 4: Degradation stages of Moldova River left shore protection: a - stone prism displacement, concrete slabs support beam breaking; b – slabs slipping on the embankment (2008).

- the shore protection was degraded in proportion of 5-10% in 2004, and in 2012 it reached 80%;
- the left bank shore protection was totally degraded in 2015 on a length of about 200 m, in which case the water was acting on the shore;
- the river bed erosion phenomenon uncovered the water supply pipes and led to their deterioration during 2010-2015.

- a series of technical expertise were carried out on the studied river sector, which highlighted the intense river bed erosion at the action of natural and anthropic factors; the research has indicated unsatisfactory behaviour of rigid shore protection structures to frequent water action in a river bed made of low cohesive rocks;

- designing and carrying out regulation and shore protection works to respond to site actions and conditions; among these are mentioned (Luca et al., 2016):

- a - increasing the burial depth of water supply pipes in Moldova River bed;
  - b - building water routing (beak) and longitudinal slope stabilising structures (bottom sill);

- c - building a shore protection made of geo-bags filled with ballast (geo-bags in contact with water have a cement supplement) placed on a fascine mattress and a geotextile fabric (Fig. 5) (Luca, 2012);

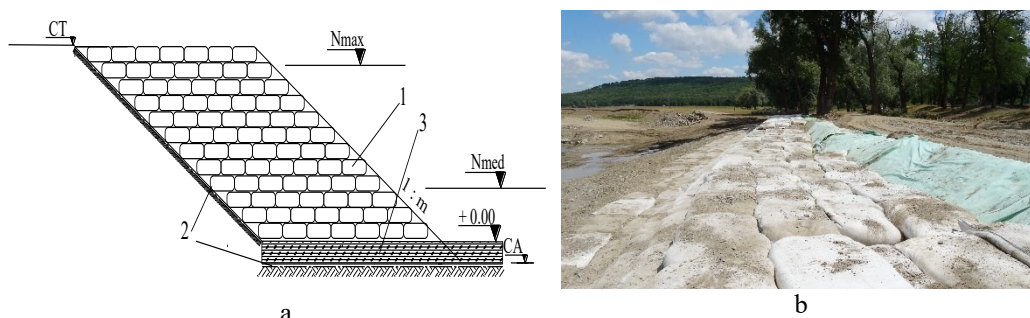
Figure 5: Embankment protection with geo-bags: a - building scheme, 1 - geo-bags, 2 - geotextile, 3 - fascine mattress; b - execution stage of shore protection with geo-bags (year 2015).

- restoration works for regulation structures were completed in 2015.

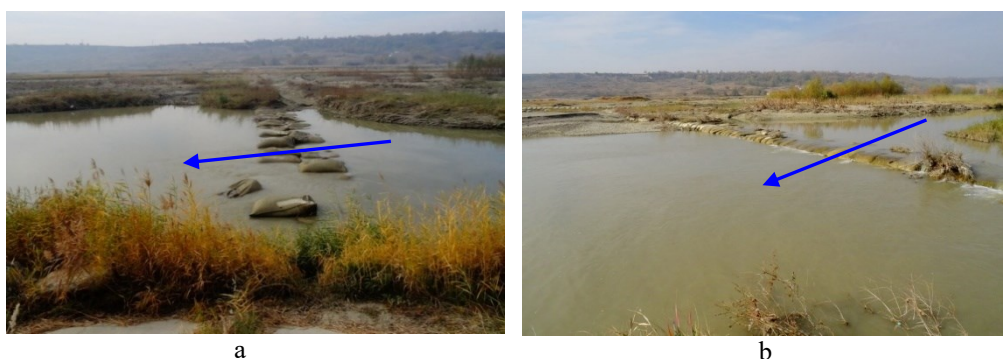
- routing dams, bottom sills, cross beams and the shore protection executed after 2006 from geo-bags were partially degraded by the action of flood water carrying solid material; the use of ballast as filler material made the rehabilitation process faster and at a lower price;

- a - geo-bags behave relatively well to medium and high waters by absorbing horizontal and vertical displacements; floaters have degraded the geo-bags structure by breaking the fabric, emptying the material, removing from site etc.;

- b - the old river bed enclosure dike and the routing dike to the new river bed are the most affected by flood transit through the direct shock reception of the water loaded with alluvial material (Figure 6);

Fig. 6. Calibrated Moldova River bed bottom sills degradation stages: a - geo-bags displacement the from the bottom sills; b - downstream view of the bottom sill (year 2018).

- the stability of the minor river bed must be ensured in the right shore area where the groundwater catchment is located on the river sector;

- designing and carrying out regulation and shore protection works that respond to site actions and conditions, which use local materials and have a low price, given their repeated degradation.

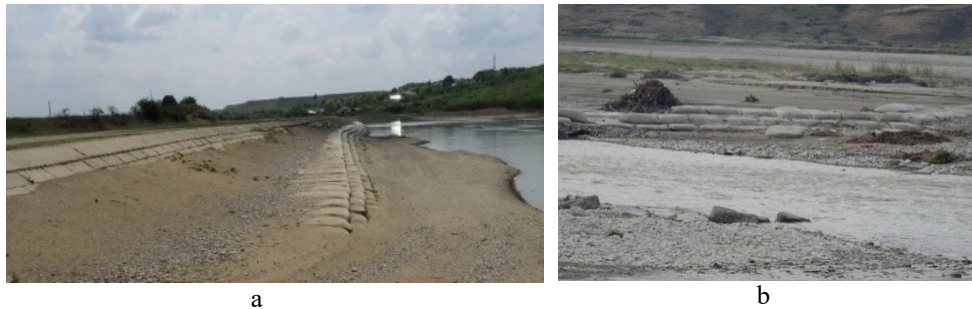
Fig. 7. General view of the Moldova River left bank in the groundwater catchment area a - shore protection structure (the old protection made of the slabs and the new one made of geo-bags); b - degradation state of the routing dike from the calibrated river bed right bank view (year 2018).
