## THE ANALYSIS OF THE FLASH FLOOD PRODUCED DURING 02-04.06.2016 IN THE TROTUȘ RIVER BASIN (ROMANIA)

**Abstract:** This paper concentrates information on the flash flood produced during 02-04.06.2016 in the Trotuș River basin. Maximum flows have been analyzed by reference to the thresholds corresponding to the Defense Levels. In order to show in a suggestive way the amplitude of the event, the characteristics of the flood were highlighted as well as a series of morphometric and hydrological data on the maximum flow of the Trotuș River. The hydrometric stations in the basin area, to which reference was made, were: Lunca de Sus, Goioasa, Tg. Ocna, Onești and Vrânceni. The flow series were represented graphically to be able to easily observe the evolution of the flood over time. The analysis showed that the flood produced on the Trotuș River had a great magnitude causing significant damages.

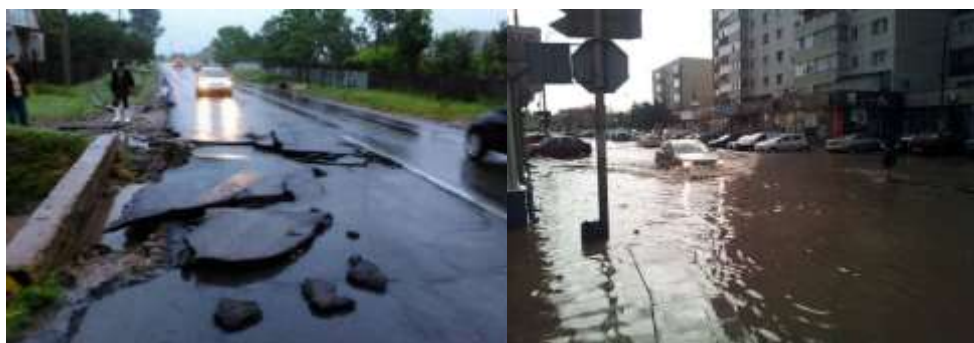
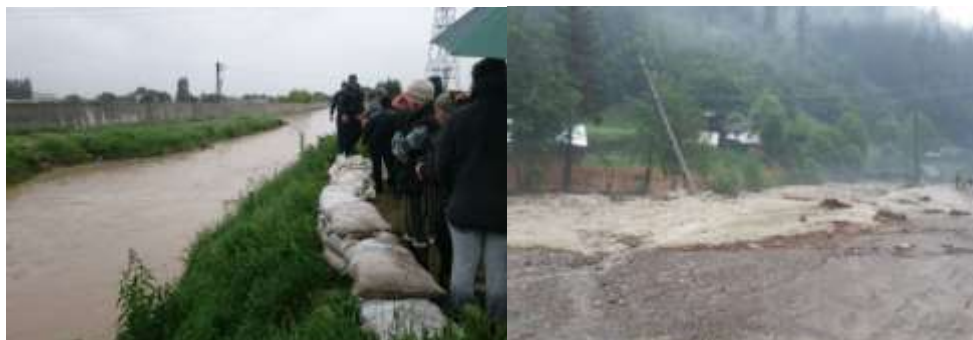
Fig.9 – Damage caused by the flash flood, Trotuș River, June 2016. Source: [www.bacău.net](http://www.bacău.net)

Also in the paper the situation of damages produced, the objectives affected (Fig. 9) and the causes of these phenomena will be presented. The following software packages were used for data processing: EXCEL, CAVIS and GIS.

On the basis of the operational report on the effects of the dangerous hydrometeorological phenomena produced during the analyzed period, a total of 23 UAT's with 61 affected villages resulted in 32 flooded houses, 442 flooded house holds, 16 isolated households, over 100 km of affected roads, 4 km of sewerage network, 26 bridges, 87 culverts, 9 decks, 1060 ha of agricultural land, 200 ha of pasture land, 0.69 km of shoreline, 3 socio-economic objectives, 0.3 km CF, a damaged gas pipe, 3 damaged salt water pipelines, one car and a deceased person. The flood affected also the hydrotechnical constructions, namely: 1 concrete pile and destroyed gabions.

Among the causes that have led to these phenomena are mainly included torrential rainfall (90 l / mp in 30 min), flow increases, leakage on the slopes, overflowing of tributaries and significant accumulations of water with sediments. During this interval, 4 orange and red code warnings were issued, of which 2 for immediate phenomena (Fig.8). Regarding the actions and interventions for diminishing the effects of the dangerous hydrometeorological phenomena

undertaken by SGA Bacau during 3.06.2016 we mention: removing obstacles by workers and unlocking of the clogged river bed, to ensure the drainage section, as well as the evacuation of the water from the flooded area.
