## STUDIES AND RESEARCHES ON MONITORING BY GIS MODELS EXTREME PHENOMENONS IN THE POPULAR CENTER

**Abstract:** The work involves the realization of a GIS model that includes both information on real estate cadastre and water supply networks. This shows the stages of making such a model, starting from field measurements, to structuring the database and custom layouts. In the study, the distribution pipelines equipped with fire hydrants and the existing building types in the area were considered as the main elements. Buildings were classified according to importance, height, destination, mapping indexes, etc. and have been integrated into the GIS model. GIS programs aim at specifying as much as possible the textual data attached to perform complex analyzes. Autocad and ArcMap programs allow you to get thematic maps on building types, pipeline network analysis on which hydrants are located, and how to protect firewalls. The study model was developed only for a sector in the city of Iaşi, but it can be extended to an application that can be used in other urban areas for the purpose of being used by the water-channel directorate, the intervention teams, the public administration local,

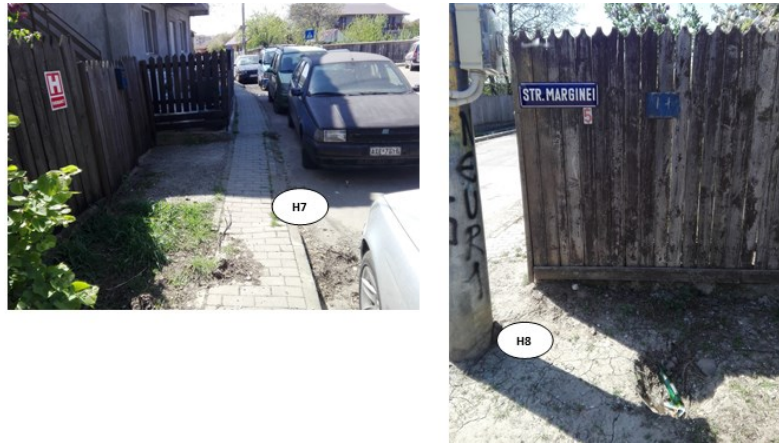
- the hydrant code H7, located on Porumbul Street, near the intersection with the Nisipari and Eagle streets, was not identified in the field; the field analysis shows (Fig. 8) the location where the H7 hydrant should have been placed and where only the signaling sign remained;

- the hydrant with the H8 code, is located on Marginii Street near the intersection with the streets of Obreja and Vulturi (secondary pebbled street); as with the H7 hydrant, it was not found in the field (only the signpost is in position);

Fig. 8 Identification of hydrants with code H7, H8 in the area "Aviation Plate"

From the field research, it emerged that of the 14 hydrants mentioned in the documents only eight hydrants were identified, one of which was canceled. By field research, the eight identified hydrants were found to have pavement location, not adequately signaled (H2, H9 hydrants), or signaling plate missing (hydrant H14). In the case of hydrants H2, H6, H9, H12 the state of degradation of the structure and of the hydraulic installation was found. Six hydrants were not identified in the field. For H7 and H8 hydrants, only the signaling plate was identified (Fig. 8).

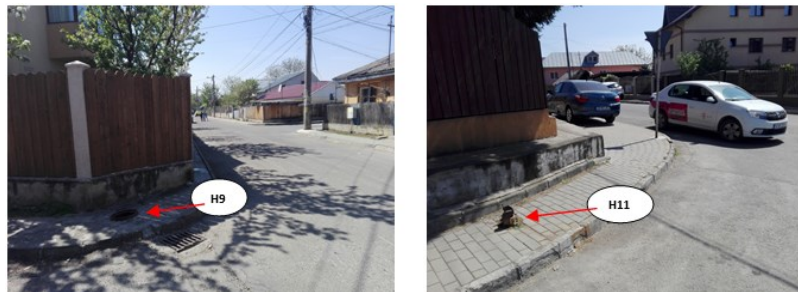
- the hydrant with the H9 code, located on Moți street near the intersection with the Obreja street, has a pavement location; the hydrant is partially degraded (no cover) and the sign is missing; the hydrant has a diameter of 100 mm, with an area of 63,92 m and an application of 0,026 l / s;

- the hydrant with the H11 code, located on Aurel Vlaicu Street near the intersection with Seven People Street, has its pavement location; the hydrant was canceled, and on the ground we only identified a part of its facility;

Fig. 9 Identification of hydrants with H9, H11 in the "Aviation Plate" area
