## LAND DEGRADATION AND MANAGEMENT WITHIN UPPER RACOVA CATCHMENT

**Key words:** soil erosion, landslides, reservoir siltation, conservation practises

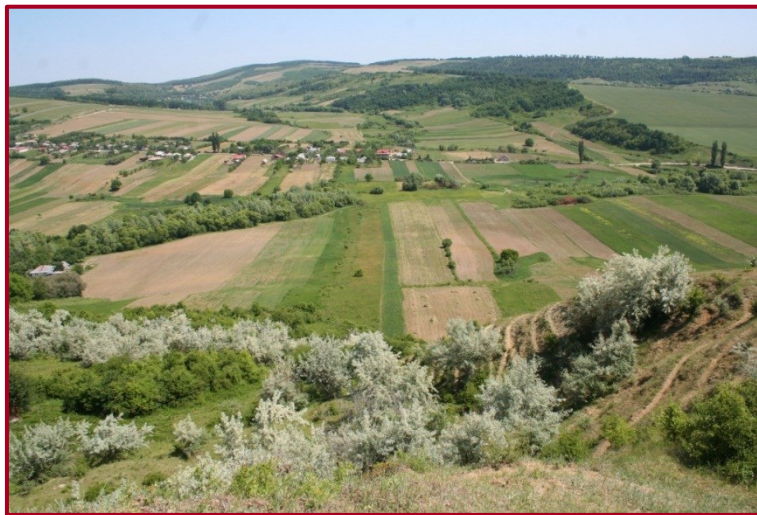
south oriented (e. g. Racovița, Hartag, Recea, Dumbrăvița) which contain smaller cuestas with west-facing fronts and east-facing back-slopes. Figure 4 illustrates the double morpho-structural asymmetry within Racova Valley, where the first order asymmetry appears in the foreground (Racova village is located on a south facing cuesta back-slope) and the second order asymmetry is visible in the background.

Fig. 4. Double morpho-structural asymmetry within Racova Valley at Racova (02 June 2015)

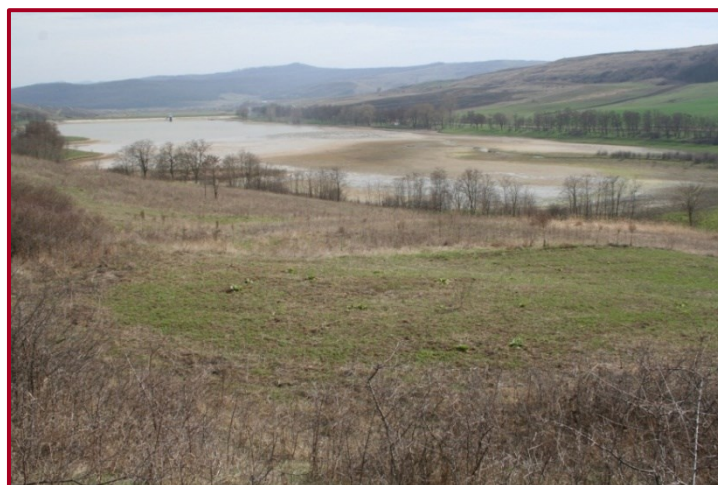
Sedimentation represents another geomorphic process with special implications on the local environment and targets floodplain aggradation and **reservoir siltation**, especially. In the context of more precipitation over 1968-March 1973, two dams were built in the study area, namely: Pungesti on Garceneanca floodplain and Trohan on Racova floodplain. They became operational in 1976 and 1982, respectively (Figure 8).

Fig. 8. Pungești Reservoir on Garceneanca floodplain (05 April 2018).

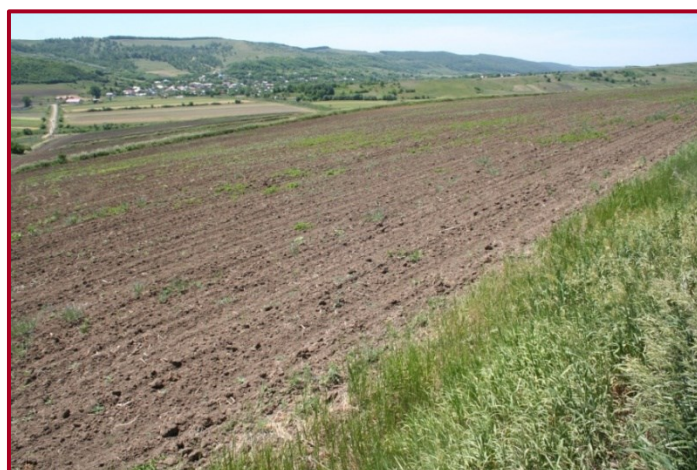
Fig. 12. Remnants of bench terraces on the left side of Racova Valley at Pungești (31 May 2018).

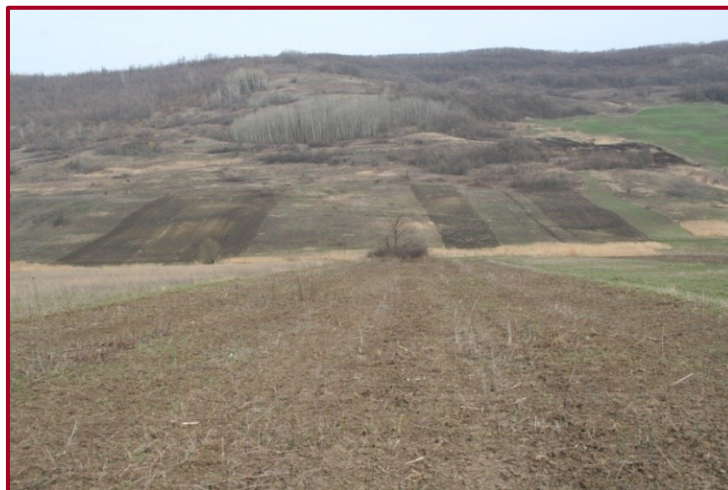
After implementing provisions of Act No. 18/1991 (of the Agricultural Real Estate), the former short-lived contour farming system almost disappeared and the ‘up-and-down slope’ farming under small plots is prevalent again (Figure 13).

Fig. 13. The impact of implementing provisions of Act No. 18/1991 in Dumbrăvița Valley (05 April 2018).
