# Vulnerability of urban floods in association with the sewage system and geographical features in the Giulești – Sârbi neighborhood, Bucharest, Romania

**Abstract:** The study aims to analyze the vulnerability of floods and their impact in the Giulești-Sârbi area, the marginal northwestern neighborhood of Bucharest. The location of the accumulation lake has hydrological importance for the studied area. The anthropogenic dam is one of the susceptible sources of floods, but the most inefficiency of the sewage system is the actual principal cause, which frequently flows back when there are significant increases in rainfall. The motivation for choosing the study is represented by the vulnerability of the Giulești-Sârbi area and by the lack of a study on flood vulnerability and frequency in the area. A questionnaire was also applied locally, some of the results being presented in this paper. The main objectives of the study refer to the spatialization at the street level of the vulnerability of floods and their following impact. It also compares the vulnerability of floods after two key periods: before and after the construction of the dam, respectively 1980 and 2020 – for the compari

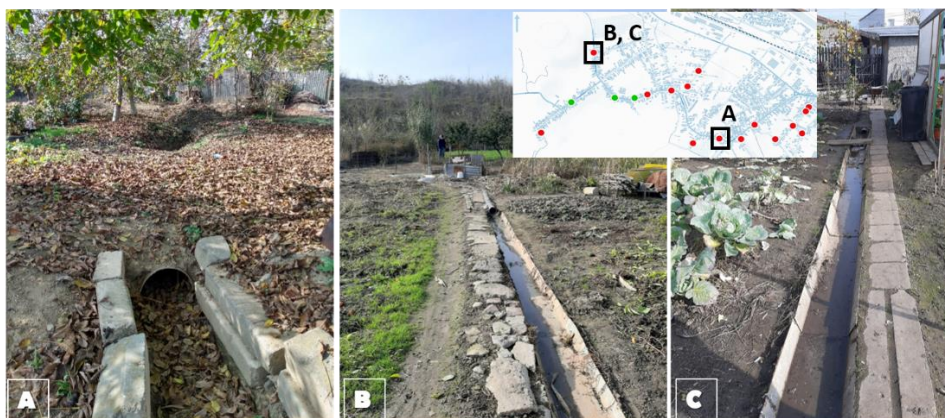
**Figure 9:** Pipes unearthed from the old sewerage system on Calea Giulești (6 Nov 2020)

During the application of the questionnaires, it was possible to observe more closely the land for some homes that inhabitants say are among those most affected by floods. Thus, it was observed that urban floods, due to the inefficiency of the sewerage system, were frequent and they occurred also in 2019 year. Figure 5 shows pipes from the sewer system that crosses the courtyards of two houses. The two houses are located on the main street of the neighborhood, Calea Giulești. These unearthed pipe segments come from the old sewer system which was largely made up of ditches. The actual sewerage system was implemented in the neighborhood around the 2000s, and these segments remained incorporated into the new system, without undergoing modernization changes.

As can be seen, the two segments pass through vegetable gardens that become inedible when, in addition to wastewater, heavy rainfalls occurred, and the system was no longer able to cope with the high flows from the two sources: gray and green water.

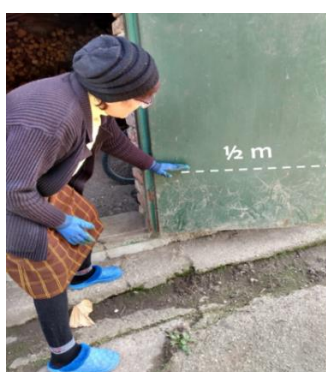
**Figure 10:** Watermark on a storeroom door on Calea Giulești (same yard like in A. from Fig. 9) (6 Nov 2020)

At least for these two cases, people have told us that the spills occur in any heavy rain, and only in 2020, there were 2-3 such events between June and September, when predominant was convective rain system. The marks left by the floods on the houses in the area are observable (Figure 10).

The impact of floods is reflected in the streets, courtyards, and gardens, which sometimes reach a level of 1/2 m as in Figure 10, thus small crops, housing and annexes are affected.

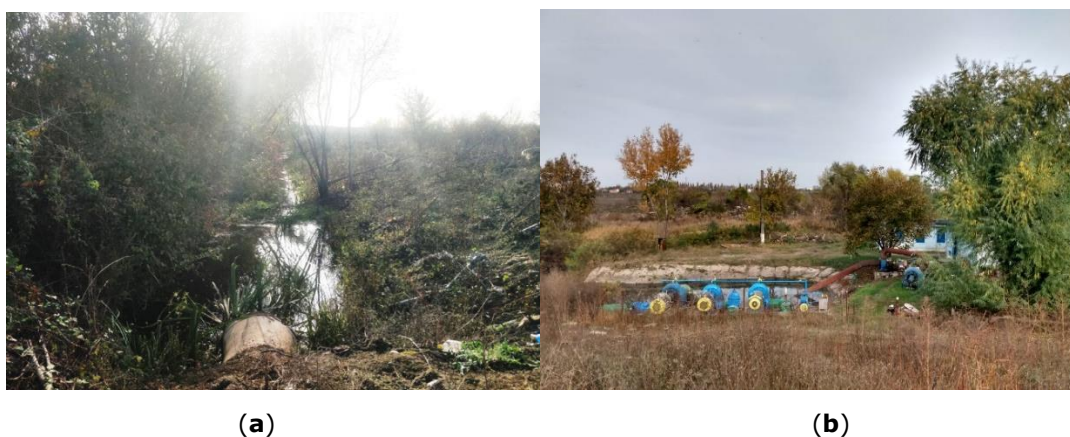
**Figure 11:** Wastewater channeled **(a)**; Wastewater pumping station **(b)** (6 Nov 2020)

Currently, the water evacuation in the area of houses is made through a canal (Figure 11 - **a**) that crosses the southern part of the studied area, reaching a station located near the Dâmbovița riverbed (Figure 11 - **b**), the riverbed, and the pumping station is separated by an earth dam that is only a few meters wide. With the help of 4 pumps, the water is directed to the riverbed (Figure 12).

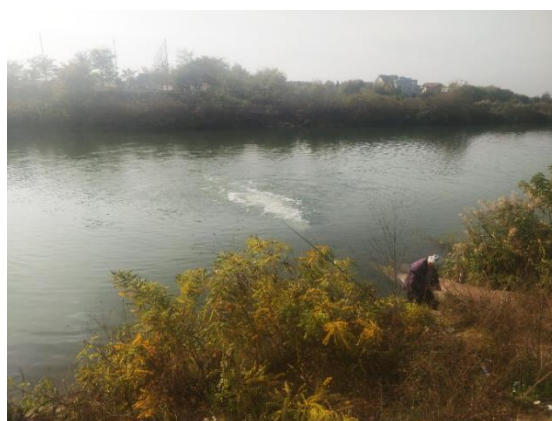
**Figure 12:** The place where wastewater flows into the river (6 Nov 2020)
