# Research on the degradation of bank protection works on mountain rivers

**Abstract:** The paper presents the results of the research on the degradation of the shore defence on the Tazlăul Sarat River. Shore defence works operate in an environment where natural risk factors collaborate with anthropogenic ones. The degradation of the shore defences was mainly determined by hydrodynamic erosion. The flow of the June 2016 flood on the upper course of the Tazlăul Sarat river was 342 m<sup>3</sup>/s, being measured at the Lucăcești Hydrometric Station. On the section of the river that crosses the town of Bolatau there has been significant degradation of the works to fix the bank and protect the road adjacent to the river bed. The shore defence in this area was made of a retaining wall made of concrete with a height of 2-5 m. The bank defence work degradation was integrated into the process of morphological transformation of the riverbed through hydrodynamic erosion. The geometrical change of the bed caused the foundation of the shore defence to be uncovered and its stability lost. The degradation of the bank protection also determined the erosion of the DC 180A communal road over a cu

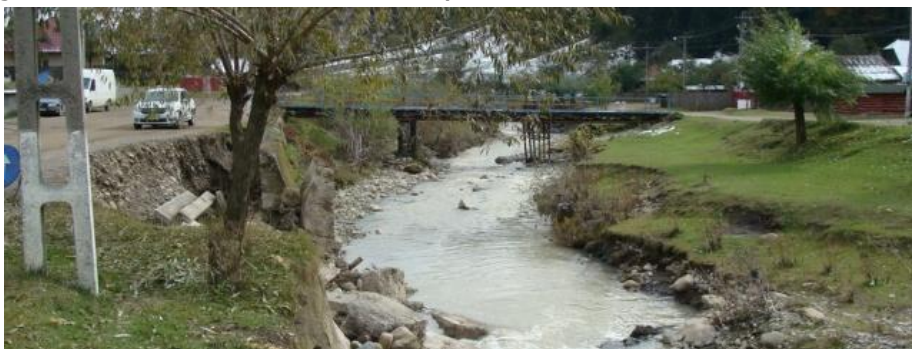
B – The riverbed is described by a narrow parabola and with an extension to a higher elevation towards the right bank (a width of 15.0 m to 35.0 m in 2016) (Figure 3). The maximum depths are located towards the left bank, where the road and the bank defence are. The riverbed is formed by rocks of different hardness (sandstones, marls, disodilic shales, clay shales, etc.), which are arranged in strongly folded structures. On these rocks there are layers of sediments deposited over time. The water current directed towards the left bank favoured the erosion of the sediments, the lowering of the bed bottom and, implicitly, the degradation of the bank defence. Rapid floods were a factor intensifying the morphological modification of the riverbed (Luca, 2016, Luca and Avram, 2017).

**Figure 3.** Upstream view of the Tazlaul Sarat riverbed in research area P1, year 2016 (Luca, 2016).

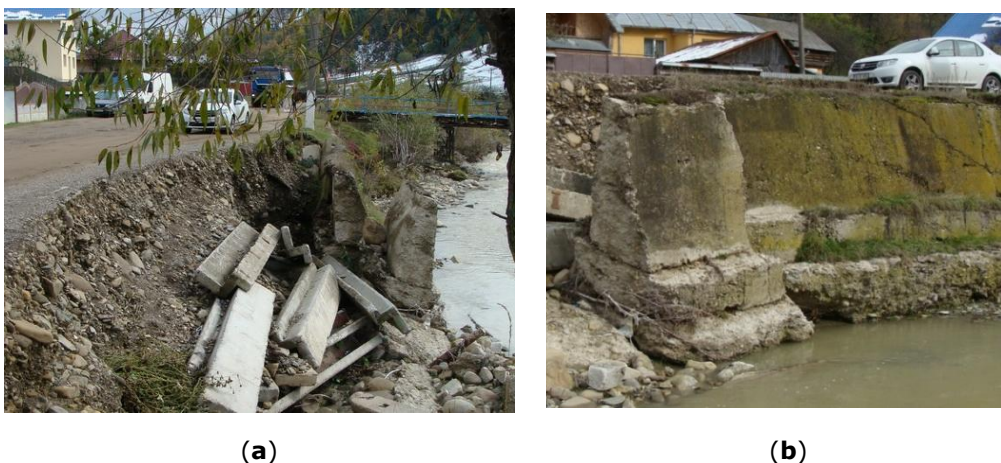
- the plain concrete retaining wall presented different lengths as a mode of degradation;
- the sectors with compact elevation but with cracks and fissures in the wall (Figure 4.b);
- dislocated wall sections in the process of collapsing into the riverbed (Figure 4.b);
- completely destroyed wall with structural elements carried downstream by water (Figure 4.a);
- the concrete in the foundation and elevation had an expired service life, which worsened the structural condition of the retaining wall.

- uncovering the concrete leveling layer, as well as the foundation of the protection work by lowering the bottom of the riverbed to depths of 0.70 – 1.20 m in the area of the contact with the retaining wall;
- modification of the supporting layer of the retaining wall caused the loss of stability of the plots, especially in the area of the curvature of the riverbed and their displacement from the normal operating position;
- the expulsion of mortar from the joints of the concrete piers, which allowed water to infiltrate behind the retaining wall and wash away the filter layer in the ballast; this situation led to the total loss of stability of the piers in the retaining wall structure;

- the tilting and overturning of the concrete piers in the riverbed, their breakage and the transportation of concrete pieces downstream.

**Figure 4.** Details regarding the mode of degradation of the bank defence at research point P1: (a) – total destruction of the retaining wall and the advance of the riverbed into the road structure; (b) – stages of degradation of the retaining wall, with its displacement from the site (Luca, 2016).

F – Conclusion: The partial and total degradation of the retaining wall was the result of the combined action of the morphological transformation process of the riverbed at average and maximum flows and the absence of maintenance and rehabilitation works of the concrete structure of the retaining wall during the exploitation period.

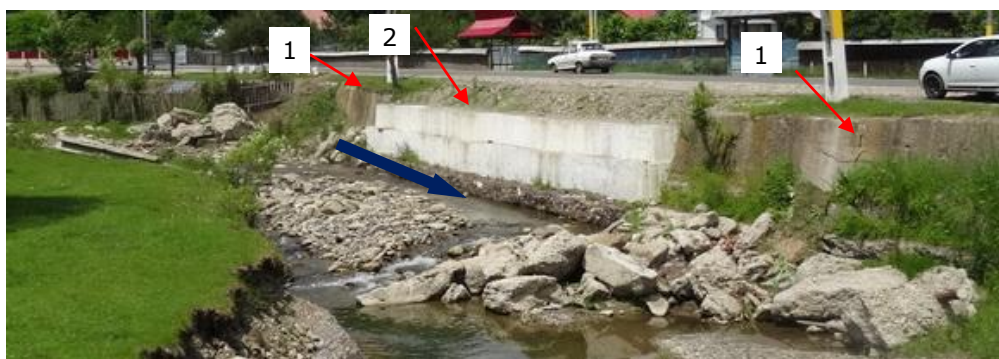
**Figure 5.** General view of the rehabilitation of the bank defence at research point P1: 1 – initial plain concrete retaining wall; 2 – sector rehabilitated with a gabion retaining wall (author's photo, 2019).

E – The completely destroyed retaining wall section was replaced in 2017 with a work of gabion boxes filled with stone (Figure 3.a). The surface of the gabion in contact with the water was protected by plastering with cement mortar (Figure 5).

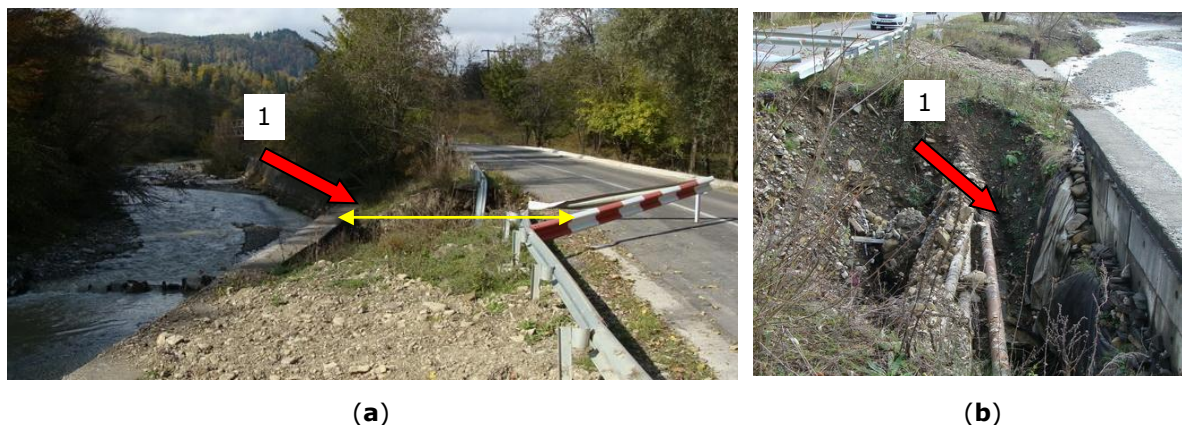
- large areas of erosion behind the retaining wall that continued into the road structure (Figure 7.a and 7.b); road traffic was limited on the road in the damaged area;

- the erosion pit extended into the riparian area and degraded the road structure.

**Figure 7.** Details regarding the degradation of the bank defence at research point P4: (a) – erosion pit behind the retaining wall and the advance of the riverbed in the riparian area, 1 – erosion pit; (b) – hydraulic installations located in the river bank (Luca, 2016).

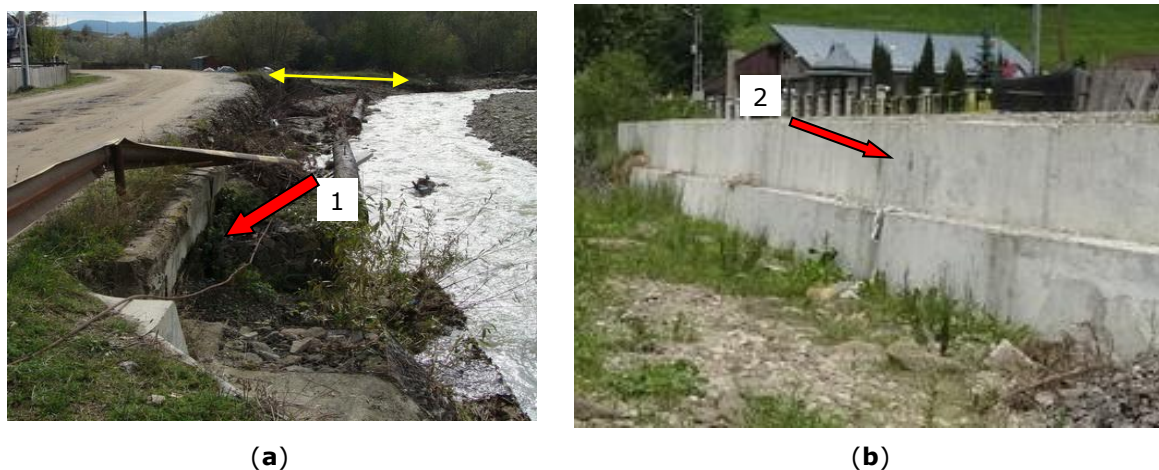
A – The retaining wall made of plain concrete on the left bank of the river (Figure 9.a), at the edge of the road, has been degraded over time.

**Figure 9.** General view of the erosion of the left bank of the Tazlaul Sarat River, research area P2,: a – upstream view highlighting the destruction of the bank defence, year 2016 (1 - simple concrete retaining wall) and the degradation of the communal road DC 180A (Luca, 2016); b – downstream view of the new bank protection work (2 - gabion retaining wall) (Author's photo, 2019).

This situation required the replacement of the old work on a limited length of the bank with a new protective work made of large reinforced concrete slabs. The curvature sector of the riverbed was not completely protected, and the flood of June 2016 destroyed the rest of the bank defence and eroded the road adjacent to the Tazlaul Sarat riverbed.

C – D - E. The results of the research on the structural and functional condition of the Tazlaul Sarat riverbank protection work analyzed in June 2016 in the P2 area highlighted the total degradation of the retaining wall. The flood also dislocated the rest of the retaining wall, eroded the bank and advanced into the road resistance structure (Figure 9.a). The riverbank protected by a new work behaved well under the flood action. The concrete retaining wall bank protection was replaced in 2017 with a wall made of gabions (Figure 9.b).

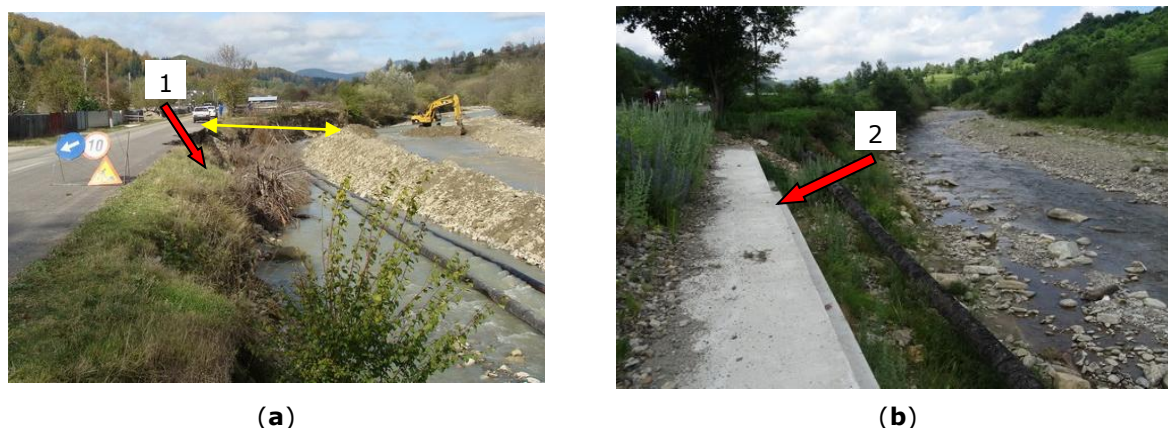
**Figure 11.** General view of the erosion of the right bank of the Tazlau Sarat River, research area P3: a – upstream view highlighting the erosion of the bank and the DC 180A road in 2016 (1 – remainder of the retaining wall); b – downstream view in 2019 of the riverbank defence rehabilitation work (2 – gabion wall located at the edge of the road) (photo author, Oct. 2019).

The rehabilitation of the degraded bank defence work (Figure 11.a) was carried out in 2017 through the execution of a gabion retaining wall, where the surface in contact with the water was plastered with cement mortar (Figure 11.b).
