## **THE CLIMATE AND ITS IMPACTS ON EGYPTIAN CIVILIZED HERITAGE: EL-NADURA TEMPLE IN EL- KHARGA OASIS, WESTERN DESERT OF EGYPT AS A CASE STUDY**

**Key words:** Roman monuments; El- Nadura Temple; Weathering forms; deterioration

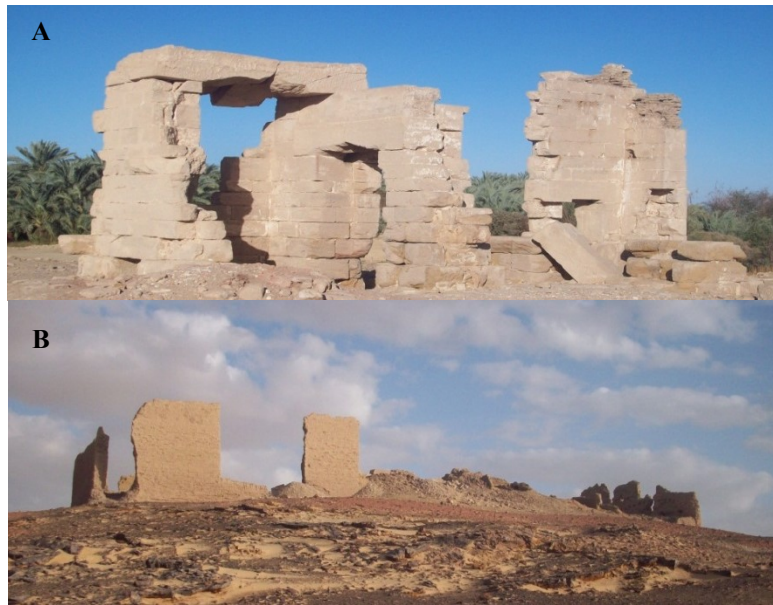
(Fig.2 A.B) Panoramic view of El-Nadora temple zone, (A) lower structure uninscribed and its dedication function are thus far unknown (B) The main temple surrounded by mud-brick walls

modern designation El-Nadora may refer to its function as a "look-out" post for the Darb El-Arbain north-south caravan road that connected western Sudan with Upper and Middle Egypt (Fig.2B).

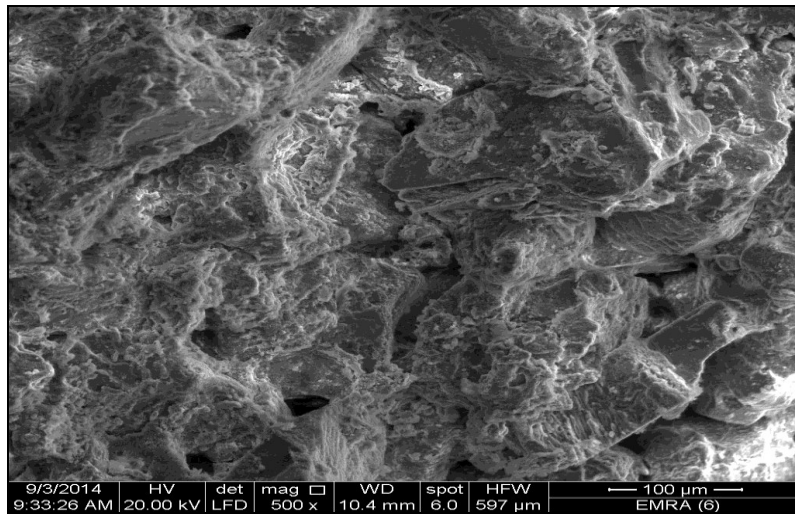
(Fig.3) Scanning electron micrograph of deteriorated stones of El-Nadara Temple showing Crystallization occurs initially in the small and large pores

below the dew point. High temperatures during the days draw the moisture out of pores towards the surface. This water evaporates, with resulting crystallization producing forces adequate to weaken or even disrupt the stone (Fig.3).

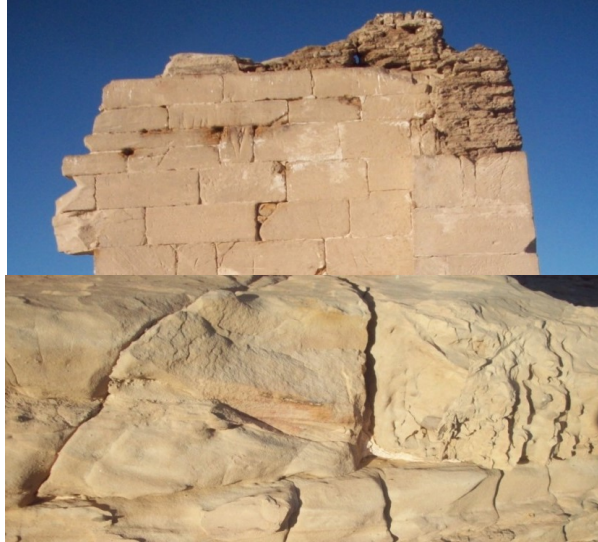
Fig. 4. A, B. Longitudinal single cracks on the wall of El-Nadira Temple, millimeters in width and centimeter in length, due to arid climate and wide range of temperatures.

Cracks are more effective features of weathering resulting either from the effect of mechanical stress due to crystal growth or biological growth (El-Gohary, 2010). Several longitudinal single cracks are observed on the vertical wall of El-Nadara Temple, cracks are typically several millimeters in width and centimeter in length, due to arid climate and wide range of temperatures with very hot days and very cold nights (Fig.4 A.B).

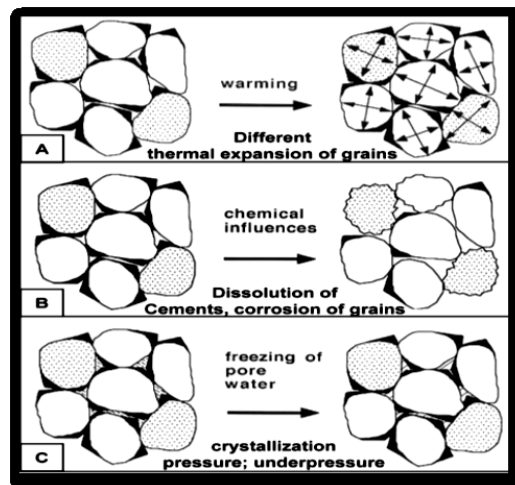
Fig.5. Basic systems deteriorated stones texture in the weathering of rocks. After: Roman Koch, 2008

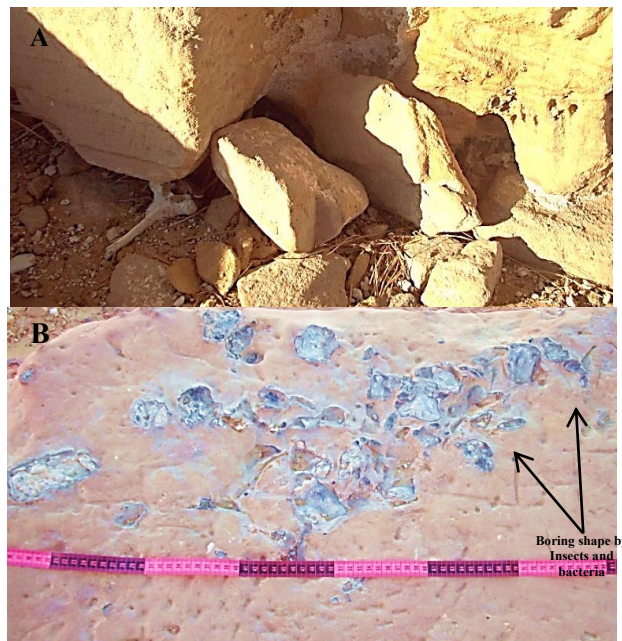
Fig. 6. A. B Biological deterioration at El-Nadora Temple showing boring shape by animals in (A), boring shape by insects, bacteria and fungi effect in (B)

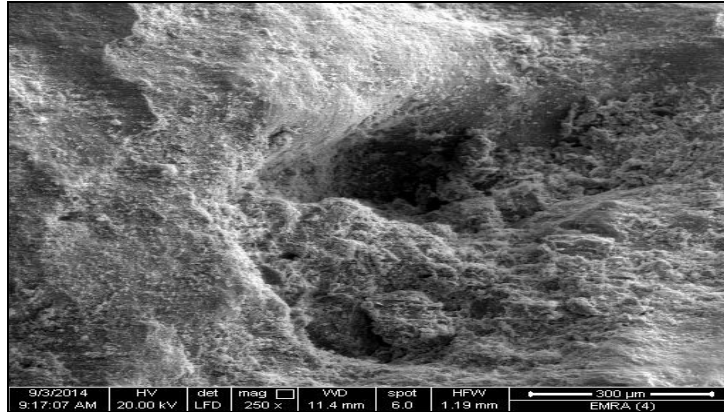
Fig. 7. Scanning electron micrograph of deteriorated stones of El-Nadoura Temple showing micro pitting occurs initially in the small pores

little loss of wall stones with small effect on its surface, while it damages the deep structures of the monument stones ([sk.wikipedia.org/wiki/Petting](http://sk.wikipedia.org/wiki/Petting)). Pitting is a result from the action of some biological factors (insects and micro-organisms). The feature of the biological deterioration by some animals such as dogs and donkey, as well as some insects such as big ants, are represented by bores (few mm up to cm) into building stone of E-Nadora Temple (Fig.6 A, B), mechanical scratching and acid secretions (Abdel-Tawab and Mahmoud, 1992). Deferent kinds of organisms can grow using the mineral components of stones and its superficial deposits. The climate elements, especially the wind caused pitting feature of the wall stones of El-Nadora Temple through grains abrasion. Small pits about 0.5mm are noticed on some block facing the prevailing wind, other pits have other modes of origin such effect may increase where holes are developed with final complete destruction of the structure (Fig. 7).

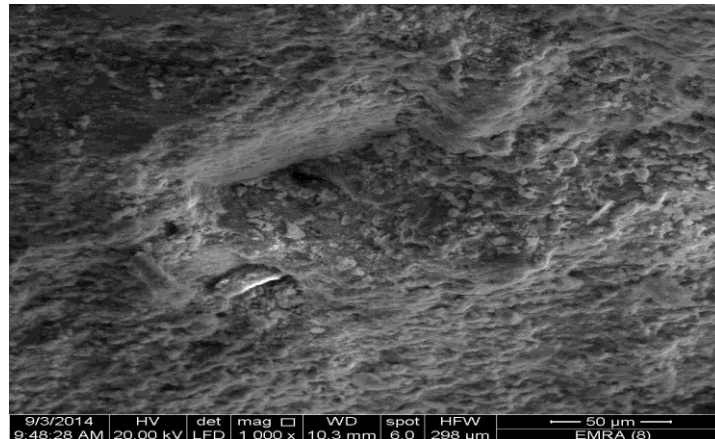
Fig. 8. Scanning electron micrograph of deteriorated stones of El-Nadoura Temple Showing micro-exfoliation grains

According to (El-Gohary, 2010), exfoliation is a type of physical weathering in which the outer layer of a rock surface peel off in flakes and shells. It is caused by the rapid expansion and contraction of the rock surface when subjected to extreme change of temperature. Exfoliation occurs particularly in hot dry climates as a result of thermal expansion, so it can observed this type of weathering in El-Nadoura Temple (Fig.8).

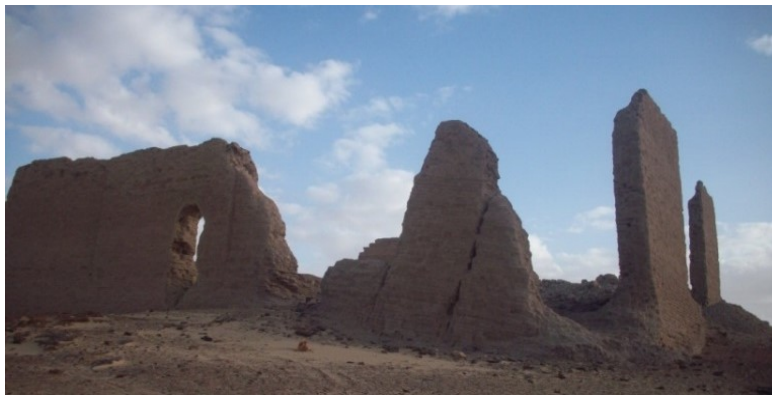
Fig. 9. The presence of structurally unstable walls at El-Nadira Temple as a result of physical weathering (natural causes), or constructional causes

A complex combination of mechanical, chemical and biological factors played an important role in the deterioration of building stones of El-Nadira temple walls, such as unstable walls (Fig.9). The processes of mechanical deterioration affecting the calcarenite and the aeolianite building stones are boring, abrasion, polishing, scouring, scratching, splitting, fragmentation and rock fall (Fig.10). These processes are reflected by striations, polished surfaces, undulating surface, cracks, fissures and joints and finally rock fall (Mahmoud, 1995).

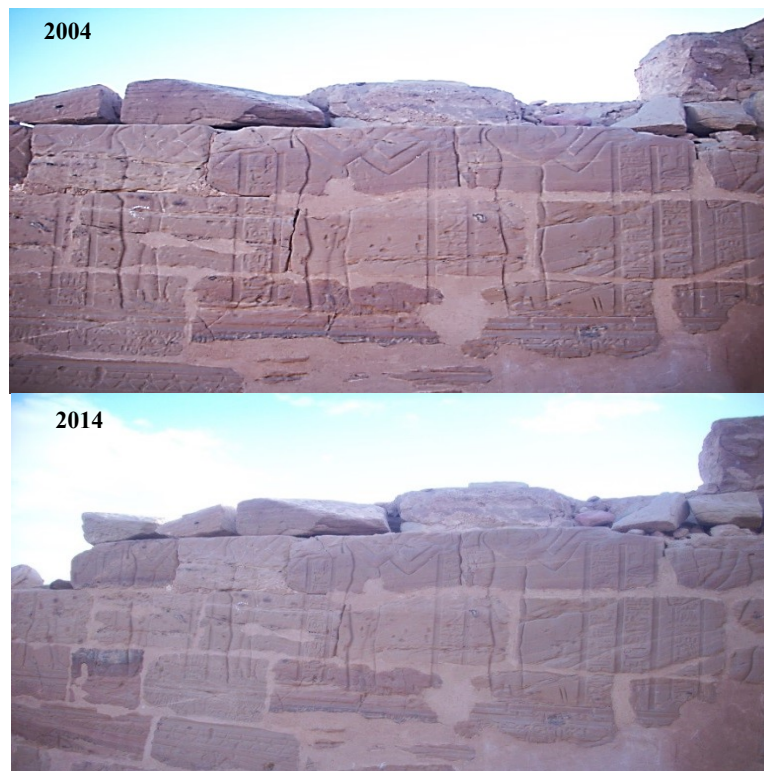
Fig. 12. Progress of clarity of archaeological inscriptions and texts as a result of the deterioration caused by the wind carrying sand between the years 2004-2014

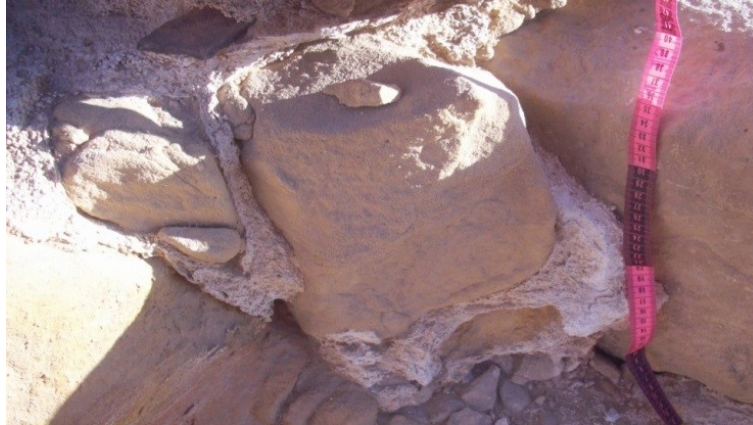
Fig. 13. Disintegration of the mortar used in jointing the stones wall at El-Nadora Temple as result of climate conditions

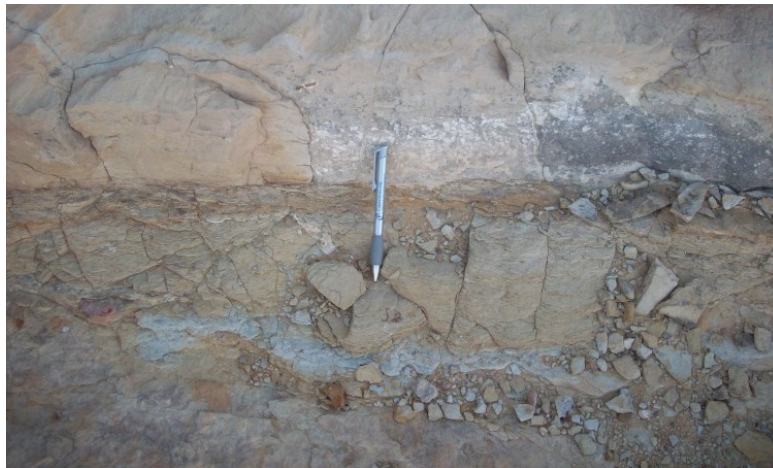
Fig. 14. Detachment of small, flat, thin pieces of the outer layers (Flaking) of El-Nadora Temple stones

Chemical weathering erodes the stones changing their compositions by chemical reaction. Chemical weathering of the stone takes place through dissolution, hydrolysis and oxidation processes of the stone minerals. Chemical weathering is mostly due to the effects of climate conditions, and caused a lot of deterioration features, such as disappearance of the texts, symbols, inscriptions (Fig.11) and (Fig.12). Disintegration of the mortar used in jointing the stones wall (Fig.13), or flaking the stone (Fig.14). Biological weathering can be described as a

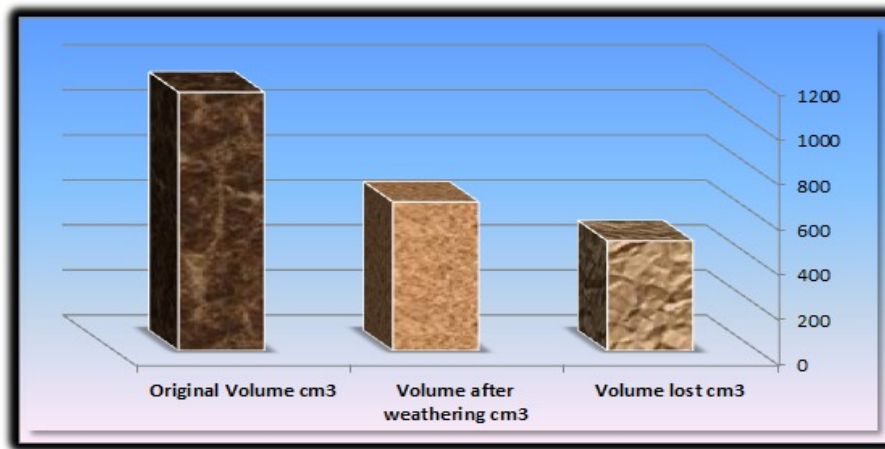
Fig. 15. Average volume of weathering related to total average volume of rock at El-Nadoura temple.

weathering and other blocks which highly weathered, then measured the length, width and depth in each block to determine the volume. Therefore, the rate of weathering was measured for six building stone blocks at El-Nadoura Temple which have an age of 2152 Year in 2014. The total weathering rate according to the age of El-Nadoura temple is  $518 \text{ mm}^3$  per year from 138 BC to 2014, and this means that the temple faces a real risk of the elements of the climate (Table.2), (Fig. 15).

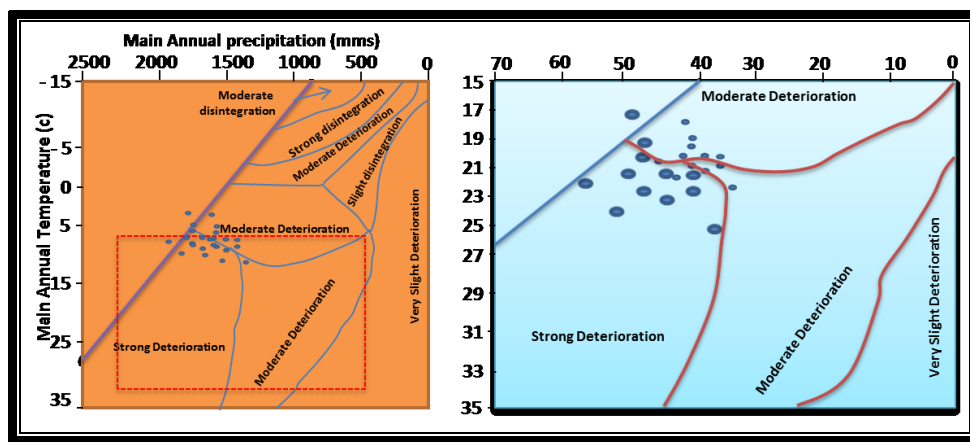
Fig.16. Correlation diagram between climate and Deterioration affecting El-Nadoura Temple  
Modified after Fookes et al., 1971

In order to examine the influence of climate conditions on cultural heritages, this study applied the correlation diagram of climate conditions and weathering designed by Fookes et al. (1971). Using the data collected for the last 60 years on mean temperatures and precipitations. As a result, the regions influenced by El-Kharga climate conditions are classified into three groups: strong deterioration, moderate deterioration and very slightly deterioration (Fig.16).

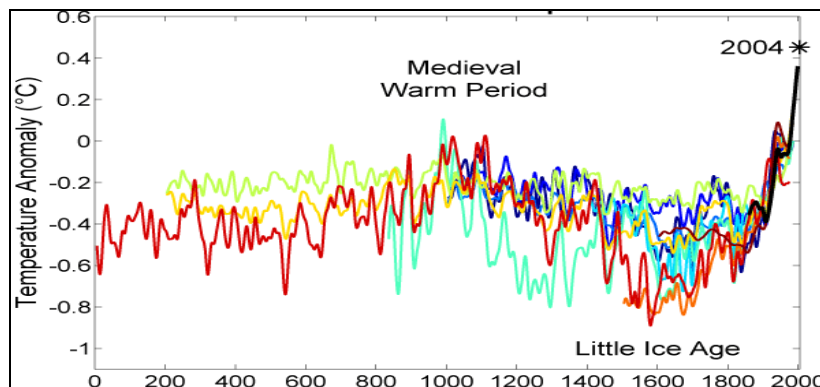
Fig.17 Global surface air temperature change since 2000 years  
(After Mgely, 1984)

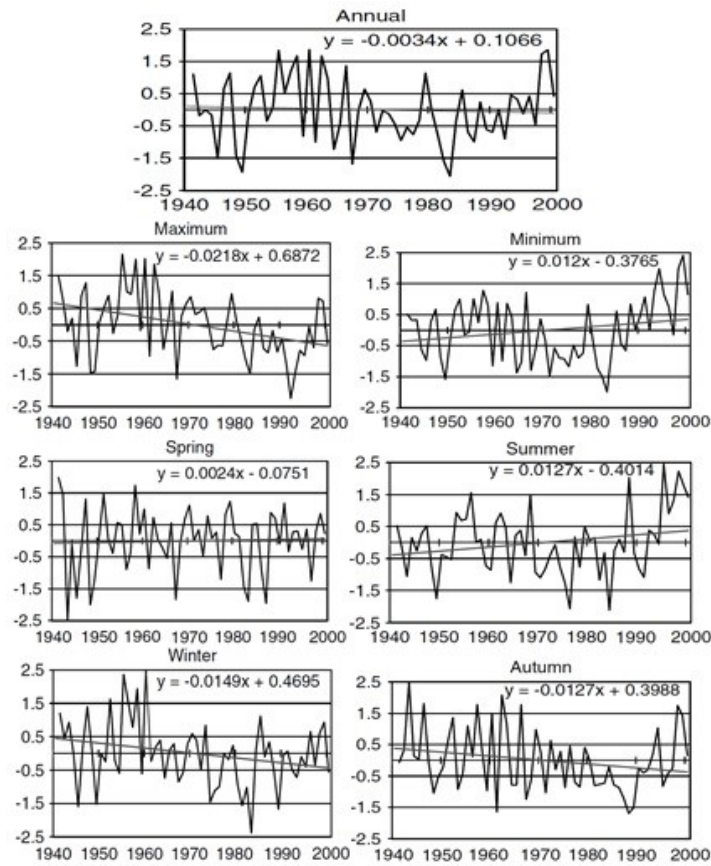
Fig. 18. Recent temperature trends for all Egypt from 1941 to 2000 (mean of annual, maximum, minimum, summer, winter, spring and autumn) based on principal component analysis After: M. DOMROES AND A. EL-TANTAWI, 2005

The trend behavior for both periods Over the period 1941–2000, increasing trends are observed for the minimum, summer and spring temperatures, and decreasing trends for annual, maximum, winter and autumn temperatures have been computed (Fig. 18). Compared with the global temperature trend after Jones et al. (1999) that were calculated as a positive trend at  $0.06$  C/decade, for Egypt a negative trend at a rate of  $-0.03$  C/decade was computed.
