PESD, VOL. 12, no. 2, 2018

## STUDIES AND RESEARCH ON NATURAL AND ANTHROPIC RISK THE MOLDOVA'S LOWER COURSE

**Key words:** constructive degradation, erodible riverbed, morphology, shore defence

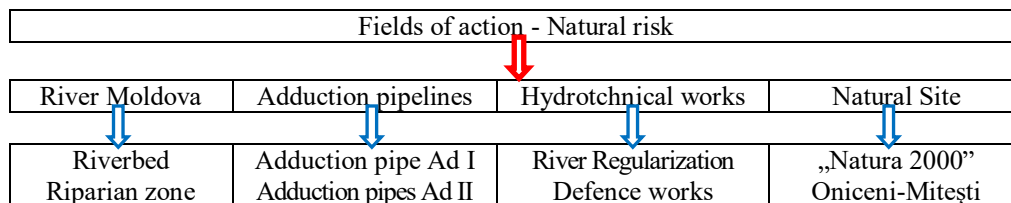
Natural risk factors and anthropogenic risk act in the area of study on the following natural, economic and social areas (Fig. 3):

- a - sector on the Moldova River (the minor bed and the riparian area) analyzed;
- b – Hydraulic installation undercrossing for the three adduction pipes;
- c - hydrotechnic constructions for riverbed regulation and shore defence works;
- d - the existing habitat in the riverbed and in the riparian area, belonging to the natural site "Natura 2000" Oniceni - Mitești.

Fig.3. Fields of action of natural and anthropic risk in the study area

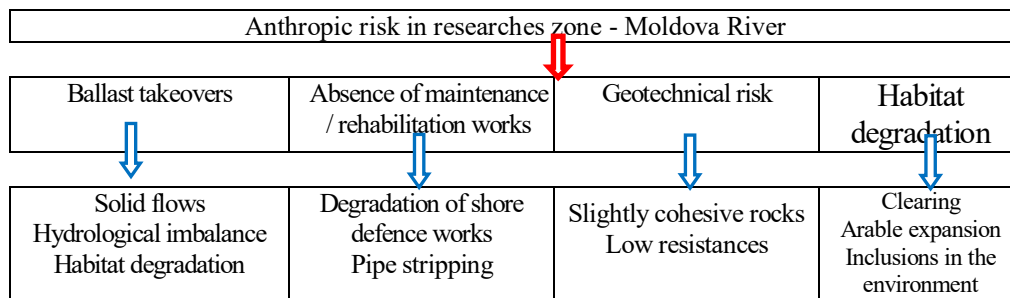
The impact of anthropogenic risk factors has been felt in the last period of time. Studies and researches in the research area conducted of levels highlight the influence of anthropogenic risk factors on the current riverbed evolution (Fig. 6).

Fig. 6. Anthropic risk factors and mode of action on the Moldova River
