## THE CHARACTERISTICS OF THE PROCESS OF "HISTORICAL POLLUTION" WITH BLACK OIL AT S.C. "MODERN CALOR" S. A. BOTOȘANI

**Abstract:** The work shows historical pollution aspects of the soil on a range of approximately 2000 m<sup>2</sup> located in the east of Botosani city at the loading platform/discharge heavy fuel oil in the enclosure thermal power company S.C. Modern Calor found S.A. This study was based on a series of works based on projects of soil and groundwater investigation in the area of the heating company S.C. Modern Audit Office found S.A. Soil contamination is the result of pollution over time, which is due primarily to faulty-urilor occurring during operation of the pipes or the sewage system in the territory of society of heating, to the lines of transport heavy fuel oil. At present, industrial pollution control, requirements imposed by Community acquis on environment, shall be carried out on the basis of directive (IPPC Directive, Directive LCP) and other techniques of the medium (BAT-s corresponding BREF, in the industrial sector). By these tools are prevents and controls in full pollution, thereby reducing industrial pollution.

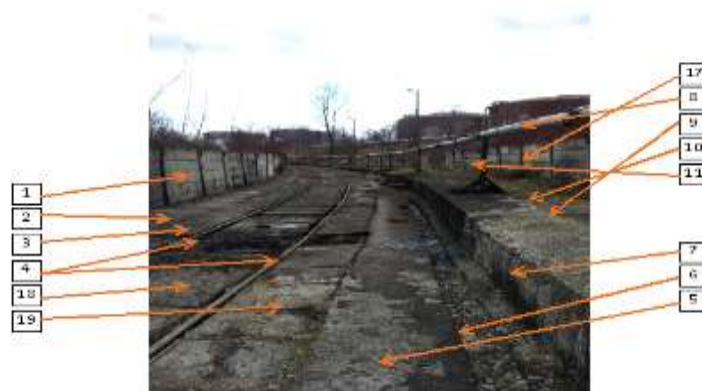
The present components of the black oil ramp are (according to the figure and transversal profile below): **1. Separation fence** from concrete slabs between the 2 rail lines. The fence is formed of 5 reinforced concrete slabs of 400x2000mm. It has 2 m height and it is pre-exalted with 3 rows of barbed wire, on metal bases. The support pillars are from reinforced concrete. **2. Reinforced concrete slabs** of 550x800x100mm. They are emplaced along the ramp, adjacent to the concrete fence. **3. Reinforced concrete slabs** of 550x800x100mm. They are emplaced along the ramp, adjacent to the railway. **4. Railways** emplaced with a 1,435m gauge with superstructure type 40.

**5. Reinforced concrete slabs** of 550x800x100mm. They are emplaced along the ramp, adjacent to the collector channel. **6. Concrete collector channel.** It is 500x250mm. The thickness of the concrete layer is 150mm. It contains waste consisting of earth, gravel, water and black oil in a viscous mixture and solid here and there. **7. Concrete channel** which contains the black oil collector pipe (15) and the metallic supports connected. It is 1000x2000mm, 1200 mm underground, and 800 mm overground. The concrete thickness is 100 – 150 mm. It is covered with concrete slabs with 100 mm thickness. Initially, this channel was drafted as being waterproof, but down the ages, this one cracked allowing the underground water, rain water and black oil leakings to leak into the channel. At present it contains waste (16) consisting of earth, gravel, vegetable material, water and black oil in a liquid mixture (in the South), viscous (to the centre of the ramp) and solid (in the North). The thickness of the waste layer range from North to South between 800 and 1200 mm. The waste is not homogeneous along the channel. In the Southern part the 2 phases of water / black oil are clearly differentiated. **8. Steam metallic pipe**, thermal insulated with coat of mineral wool and zinc coated sheet, with 150mm diameter. **9. Reinforced concrete slabs** of 550x800x100mm. They are emplaced along the ramp, adjacent to the concrete channel. **10. Concrete rain waters drain channel**, of 300+300mm and 50mm thickness. **11. Metal bases for the steam pipe** of 1500mm high. **12. Soil** (verge). **13. Coarse gravel** for sustaining the railway (railway bed). **14. Concrete sleepers** for sustaining the railway. **15. Black oil collector pipe** with different sidings and dimensions, from Dn377 (main pipe) till Dn50 (dewatering connection). Waste formed of earth, gravel, vegetable material, water and black oil in a liquid mixture (in the South), viscous (to the

centre of the ramp) and solid (in the North). The thickness of the waste layer range from North to South between 800 and 1200 mm. The waste is not homogeneous along the channel. In the Southern part the 2 phases of water / black oil are clearly differentiated. **16. Separation fence** of concrete slabs between the black oil ramp and the black oil establishment. The fence is formed of 5 reinforced concrete slabs of 400x2000mm. It is 2 m height. The supporting pillars are from reinforced concrete. The fence is disassembled on large portions, remaining only the supporting pillars. **17.Reinforced concrete slabs** between the railways. They are 1350x550x150mm. **18.Reinforced concrete slabs** of 550x800x100mm. They are emplaced along the ramp, adjacent to the railway. **19.Reinforced concrete slabs** of 550x800x100mm. They are emplaced along the ramp, adjacent to the rain water drainage channel. **Other elements on the emplacement** : *Drainage channel* – it collects the rain waters from the drain channel (10) in a drain pipe chimney placed at the middle of the ramp, from where, through a channel it undercrosses the railway the rain water is directed in the left side of the railway, in a collector channel, after the fence. From here, through a concrete trench, the rain water drains freely to the ground. Presently, this channel is completely mudded off and it doesn't perform the projected function; Hydrocarbons separator for waters come from the drainage of the black oil depot has the volume  $V=7,8$  mc and the dimensions 2m x 1,5 m x 2,6 m, with two divisions, which take the rain and technological waters in order to separate the water of black oil. The water resulted is directed to Luizaia rivulet. This separator is handcrafted realised, without technological foundation or technical project. *Metallic separator*, with volume  $V=1,5$  mc, which is emplaced at the end of the black oil unloading ramp. The black oil is manually taken and it is reintroduced in the storage tanks. In this separator there are pumped the rain waters and also the condensation water and the black oil drained from the concrete channel.

**Fig. 1.** Overview of the black oil ramp (correlation with figure 2)

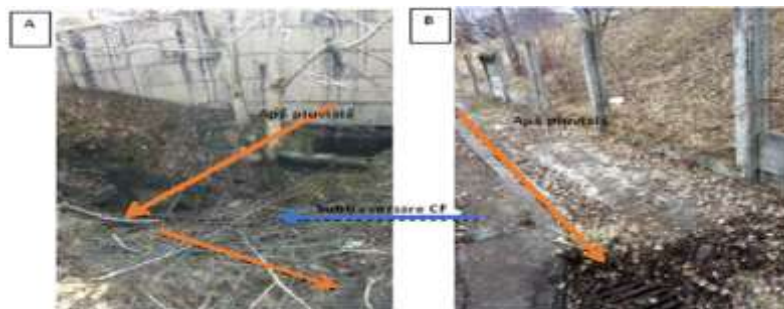
The underground water being at small depth gets into contact with the black oil leakages through the concrete channel, through the collecting channel and through the CF line. In time, there were found irizations in the underground waters down the river. In order to stop the contamination of pluvial waters, there have been proposed several solutions, including the development of a drainage channel in the left part of the railway, in order to lower the underground water level. This channel was realized but it didn't work at the designed parameters, and the problem of underground water contamination persisted. At present, the drainage channel is integrally clogged.

**Fig. 3.** Drainage channel A: in the right side of the ramp (drain pipe and chimney) and B: in the left side of the ramp, after undercrossing CF (chimney and collector ditch)

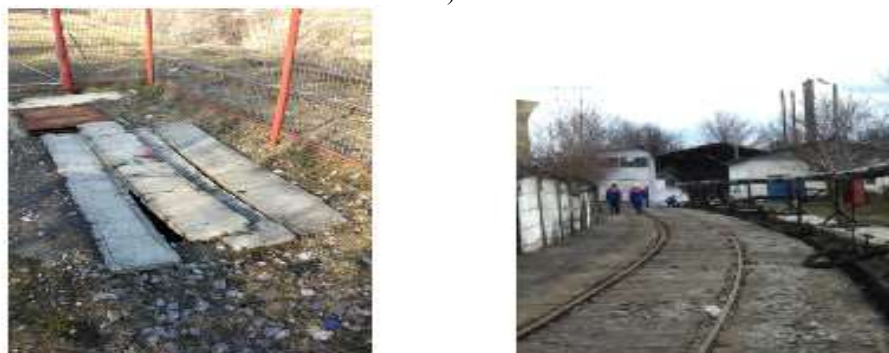
**Fig. 4.** Hydrocarbons separator (A) and metallic separator (B)

- The gravel layer (railway bed) is washed by rain and underground waters, existing the risk that the petroleum product existing in this layer to be trained and transported down the river. In order to stop this phenomenon, a hydrocarbons separator was built down the river (the Northern part of the black oil ramp), which pre-purges the drained waters on the surface of the black oil ramp. Then the pre-purged waters are overflowed in Luizoaia rivulet. The efficiency of this separator is good, taking into account the result of the analyses performed at samples from the pre-purged waters.
